# Pre Inspection Building And Timber Pest Report

**Inspection Date: 4 Sep 2025**

Property Address: 5 Tulip Place Quakers Hill 2763

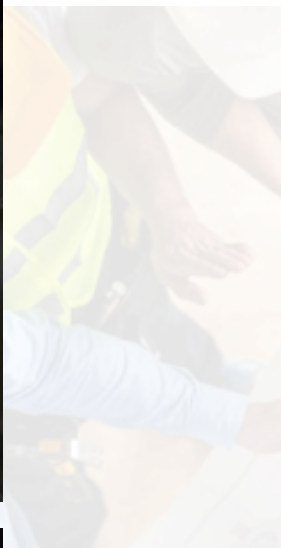
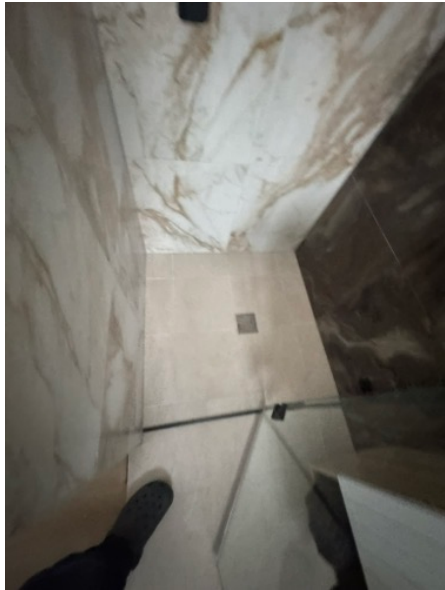
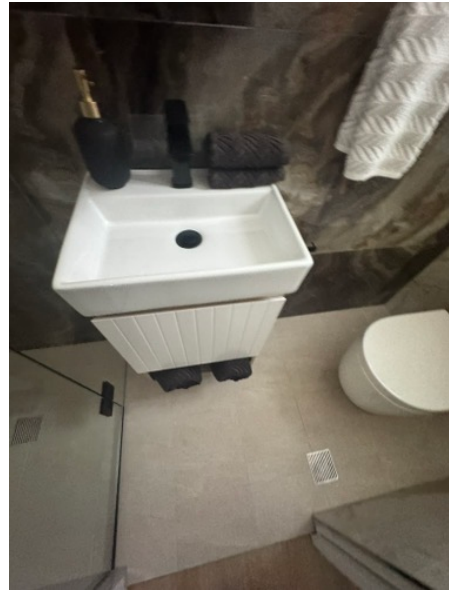
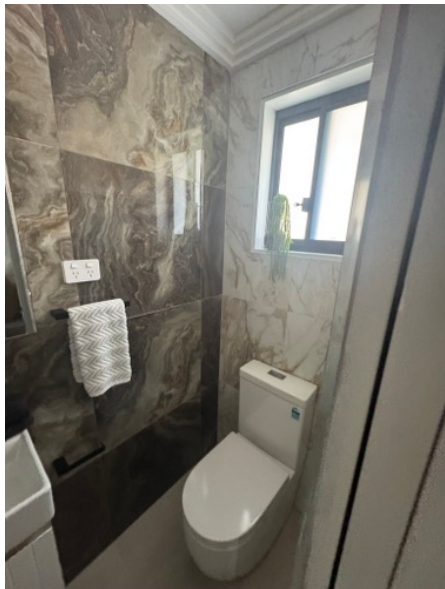
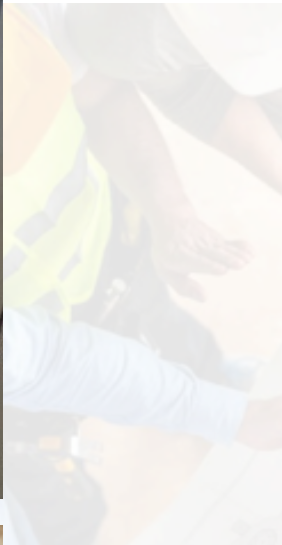
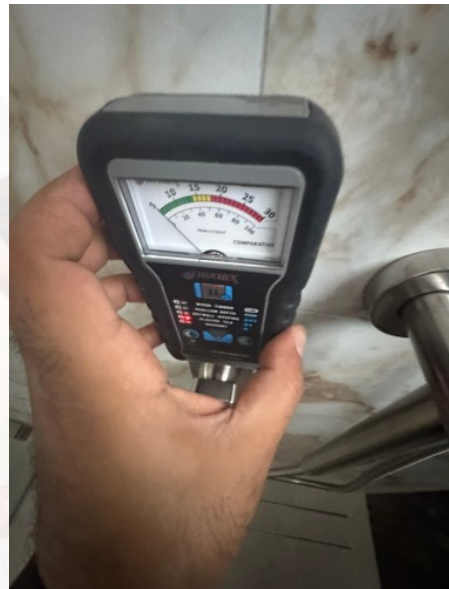
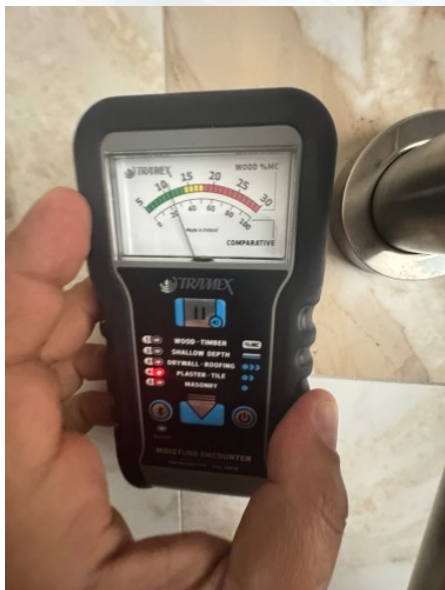
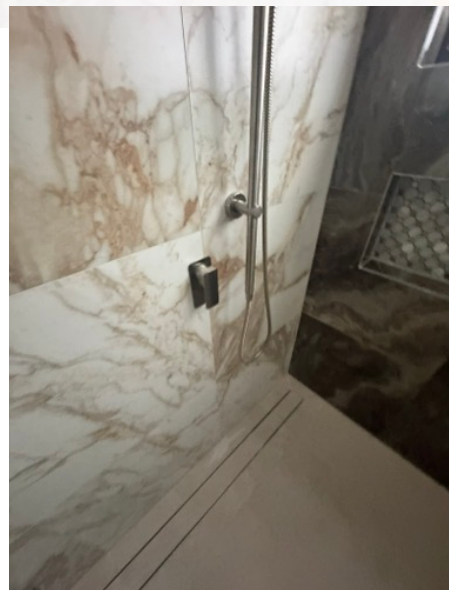
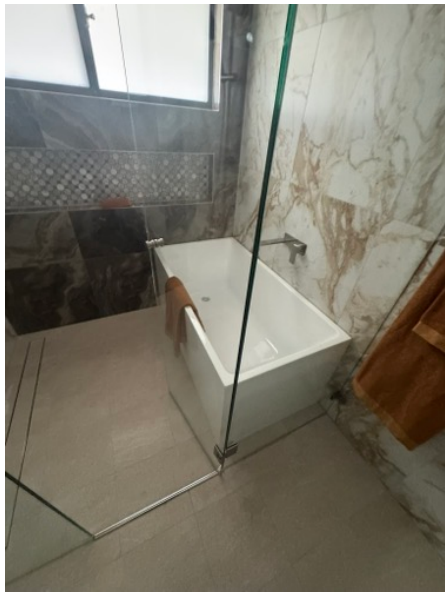
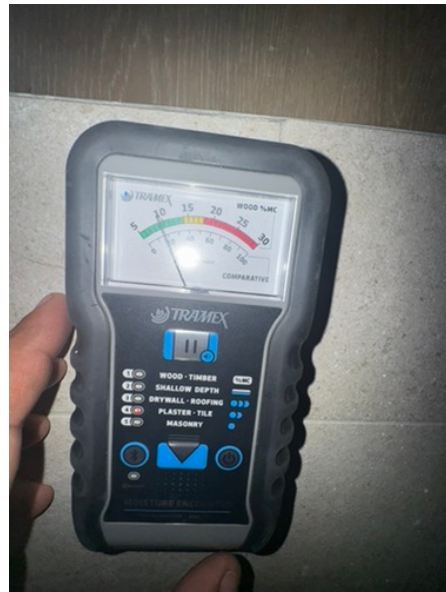
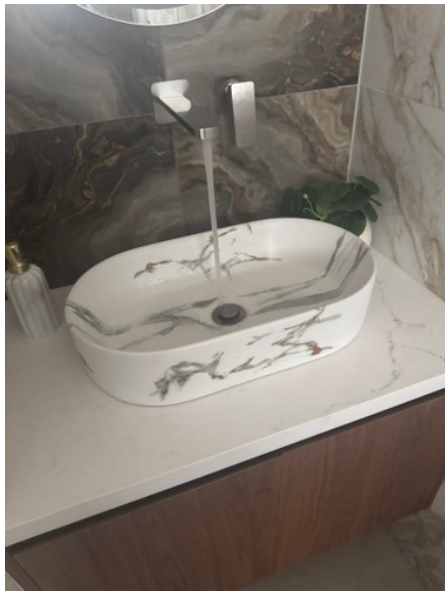
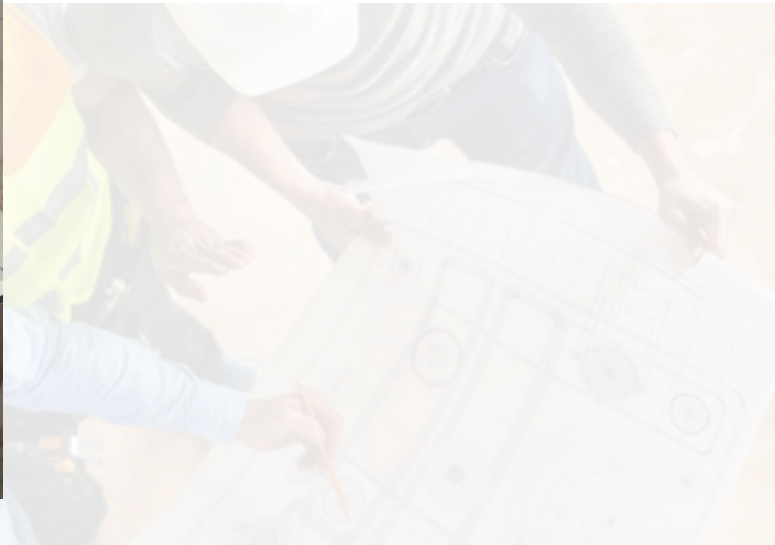
## For your information 1.01

**Location:** Bathrooms

**Finding:** Additional Photos-low moisture readings

During the inspection, moisture readings were taken in the bathrooms to assess the presence of dampness or water intrusion. The following observations were made:

It is important to note that low moisture readings in bathrooms are positive indicators, suggesting that there are no immediate water-related problems. However, regular maintenance and monitoring of these areas are still recommended to prevent potential issues in the future.

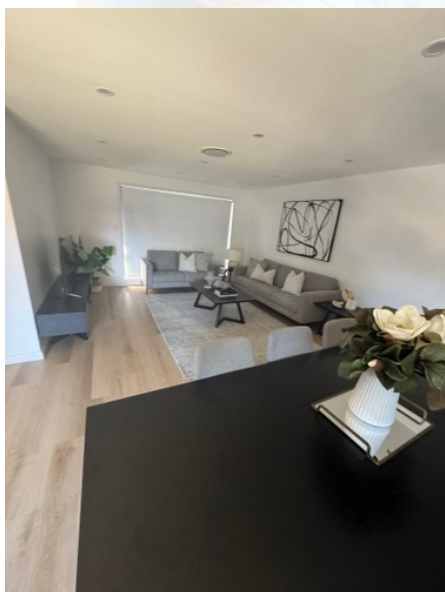
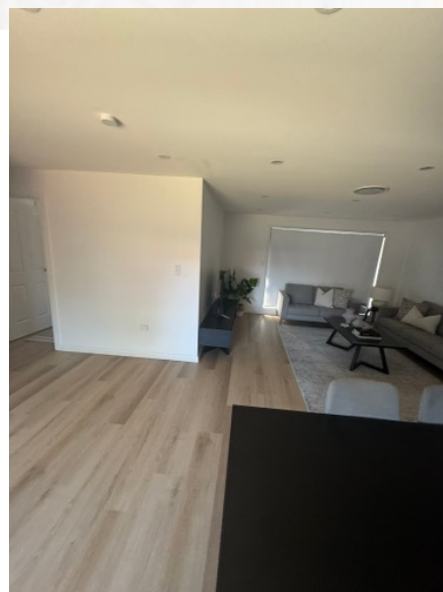
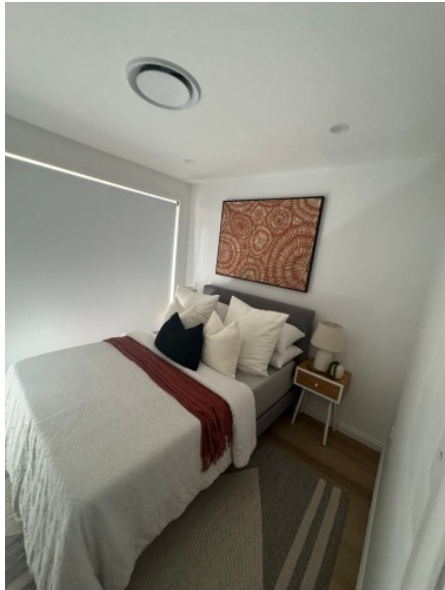
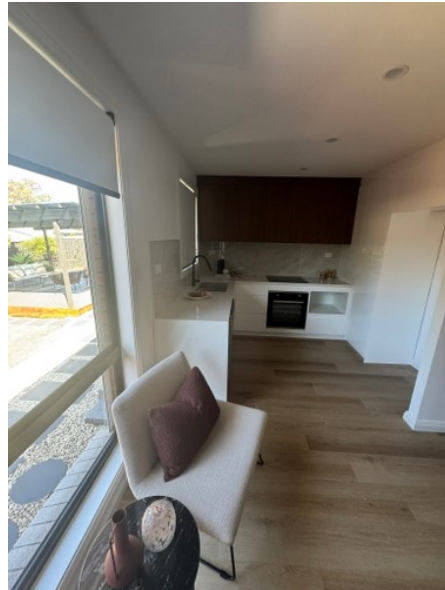
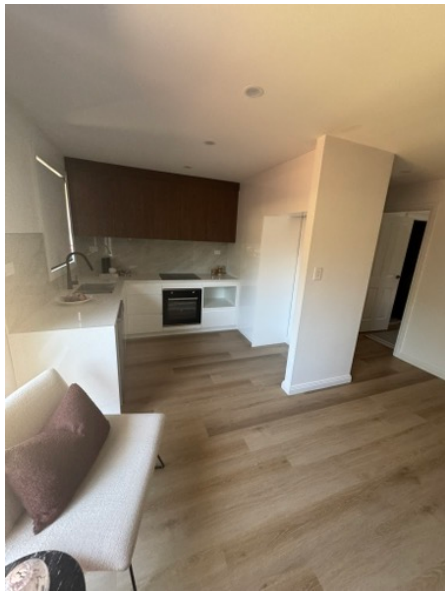
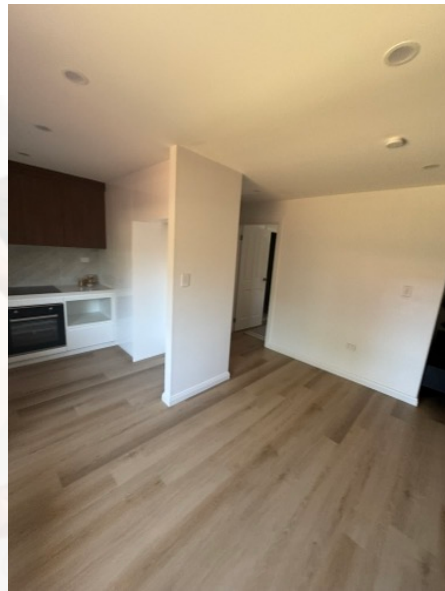
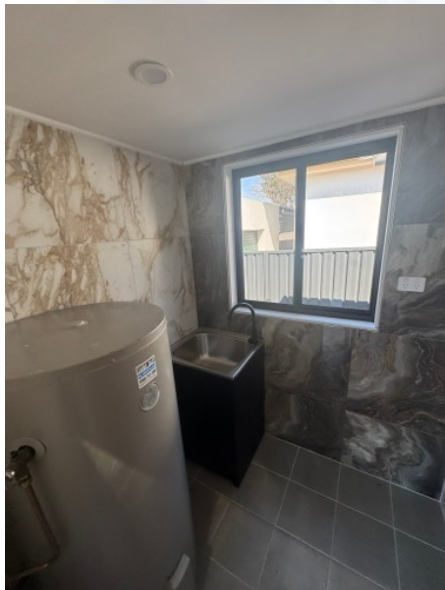
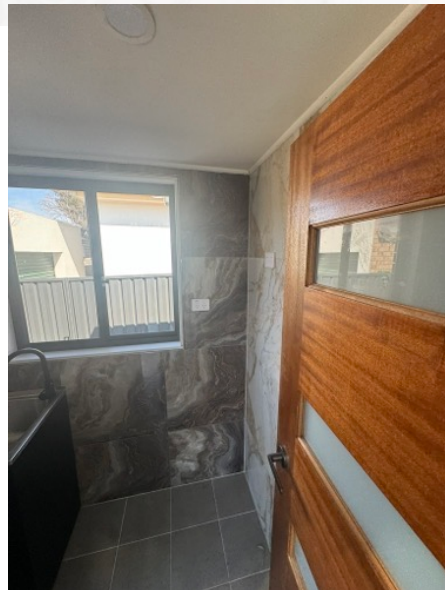
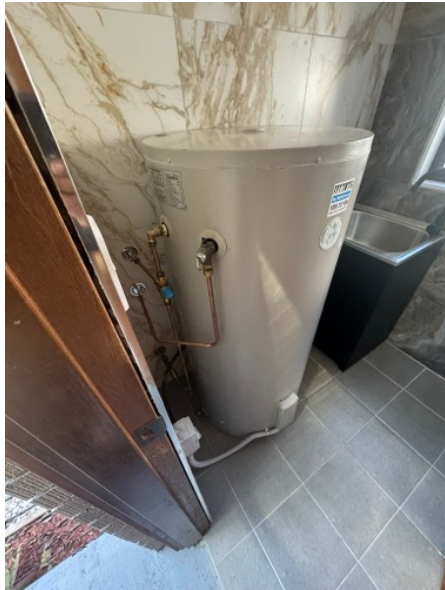
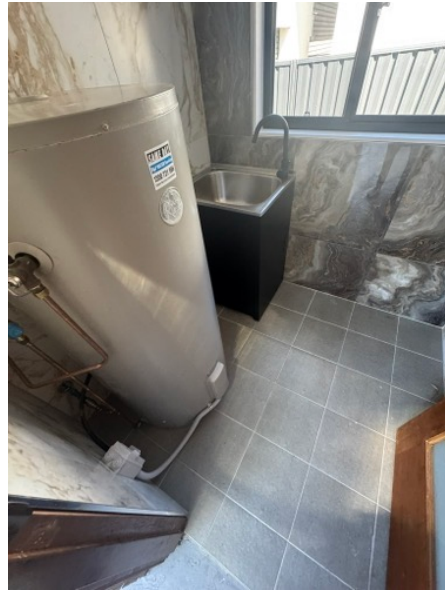
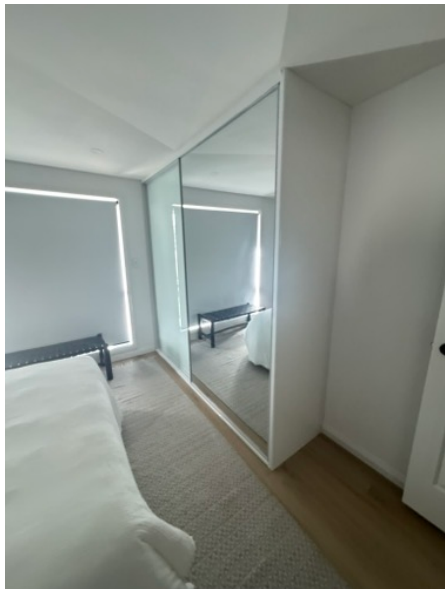
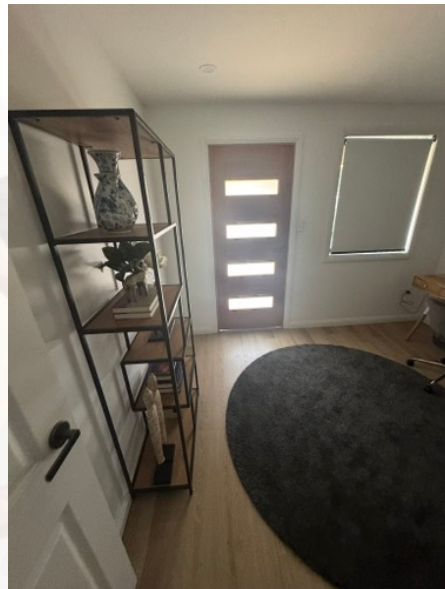
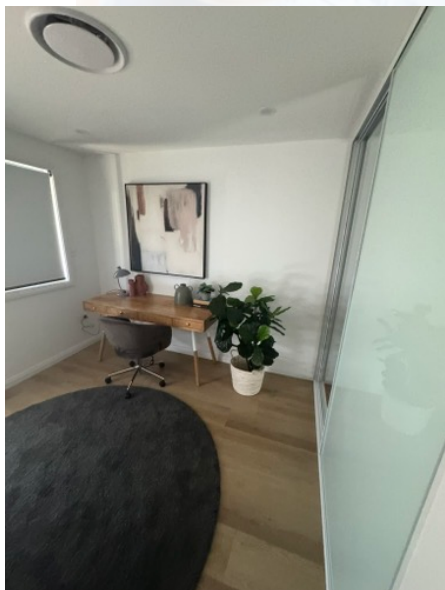
## For your information 1.02

**Location:** All Internal Areas

It is important to note that while no significant defects were identified during the inspection, regular maintenance and periodic checks are recommended to ensure the continued condition and safety of the property.

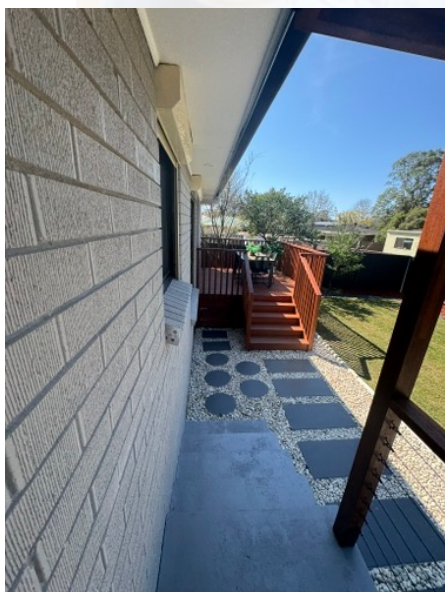
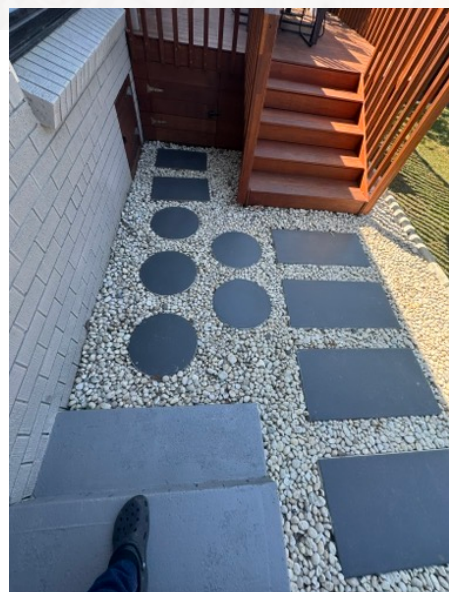
## For your information 1.03

**Location:** All External Areas

8. **Exterior Paint and Finishes:**The exterior paint and finishes were assessed for signs of peeling, cracking, or fading. The property's facade was generally well-maintained.
