# Pre-Inspection Building And Timber Pest Report

Inspection Date: 16 Sep 2025

Property Address: 8 Jacaranda Place Doonside 2767

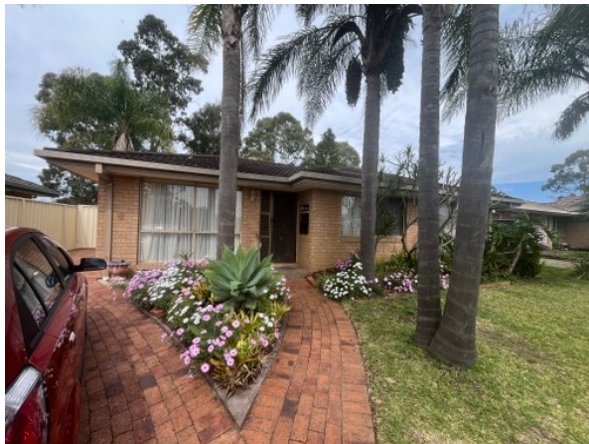
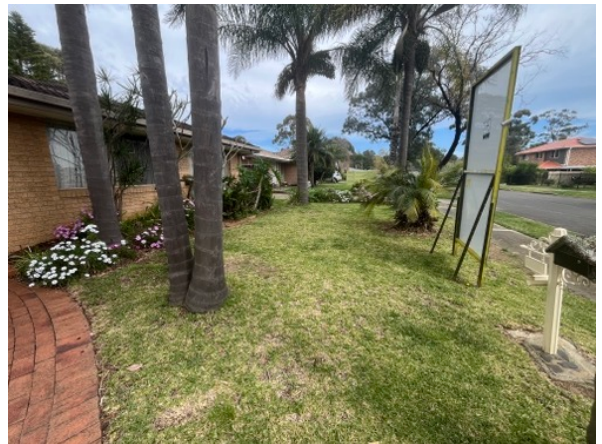
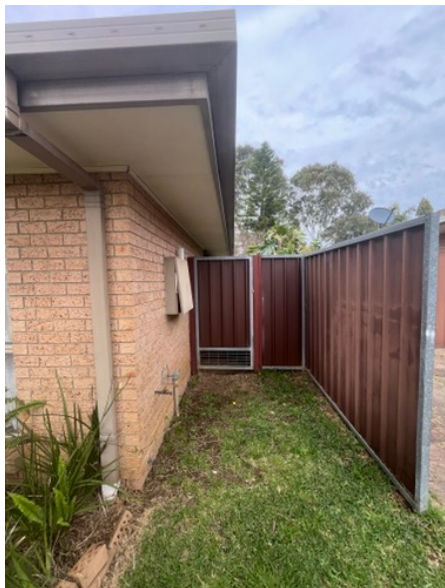
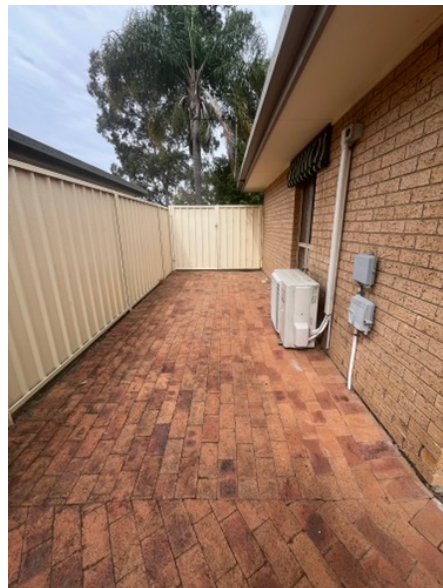
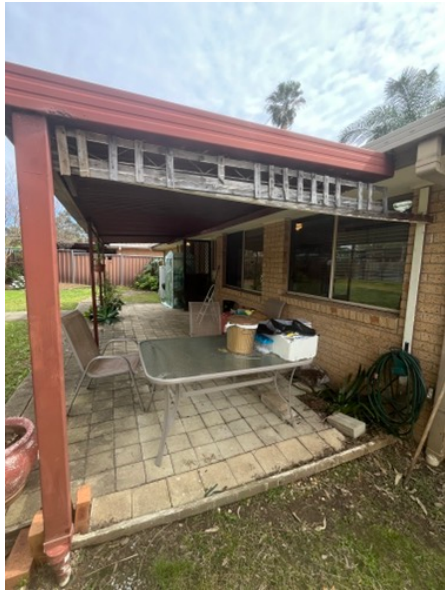
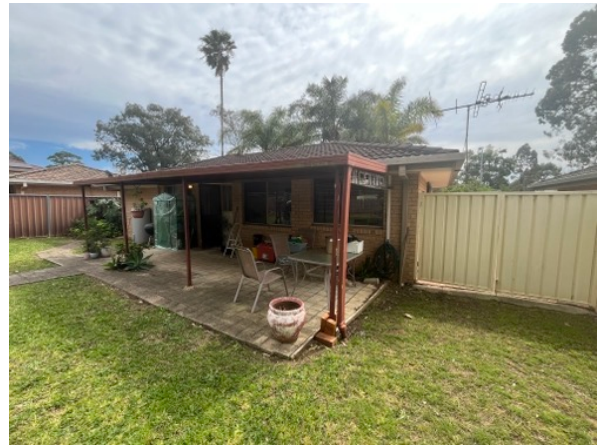
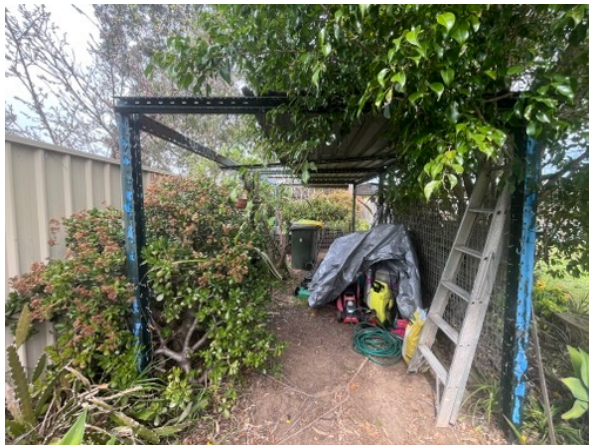
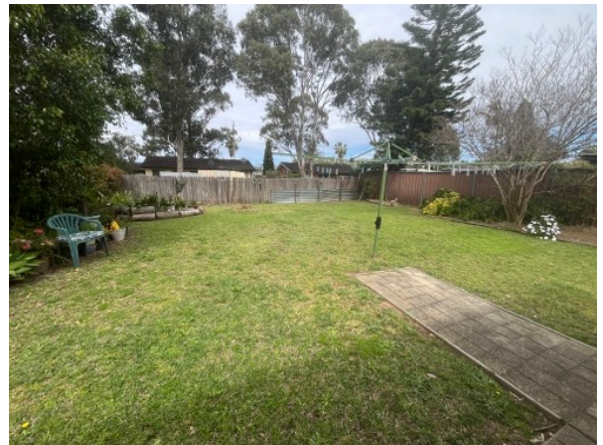
During a comprehensive inspection of the property's external areas conducted at ground level, a thorough assessment of all visible exterior components was performed. The evaluation included the exterior walls, gutters, downpipes, windows, doors, driveway, pathways, fencing, gates, landscaping, and exterior paint finishes. Additionally, whatever could be observed of the roof from the ground level was also examined.

The inspection aimed to identify any apparent minor and major defects affecting the integrity and aesthetic appeal of the property's exterior. As this was a visual inspection, the identification of issues was limited to those areas that were clearly observable and accessible. Any anomalies or imperfections detected during this process will be comprehensively outlined in the subsequent report, thereby equipping prospective buyers with the necessary information to make an informed decision regarding the property's condition and potential need for repairs or maintenance. It is paramount for potential purchasers to carefully review this report to understand all current and potential issues, thereby safeguarding their investment in the property.

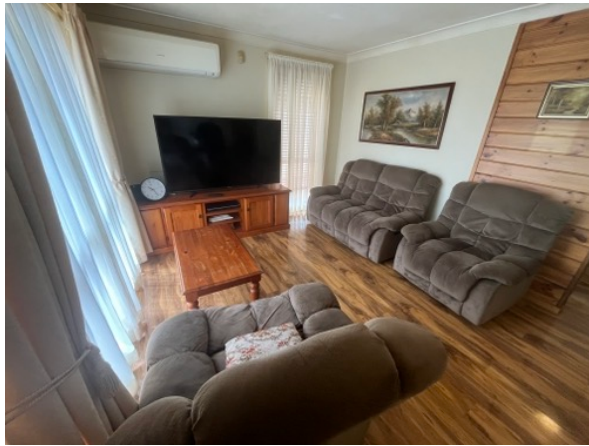
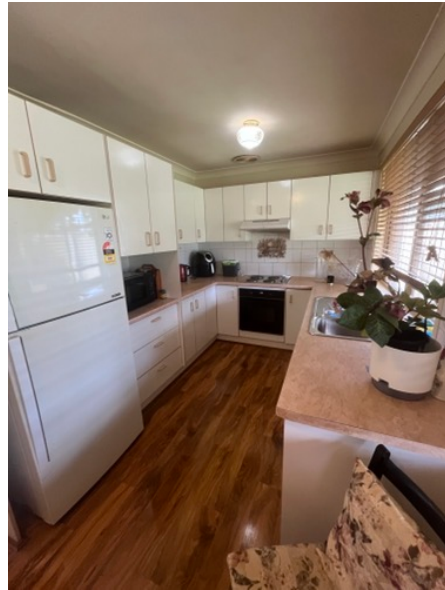
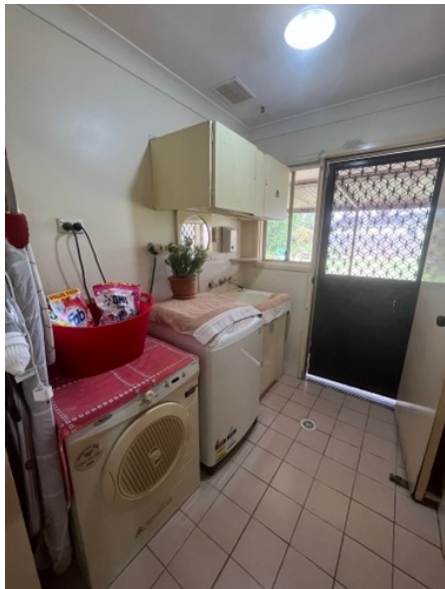
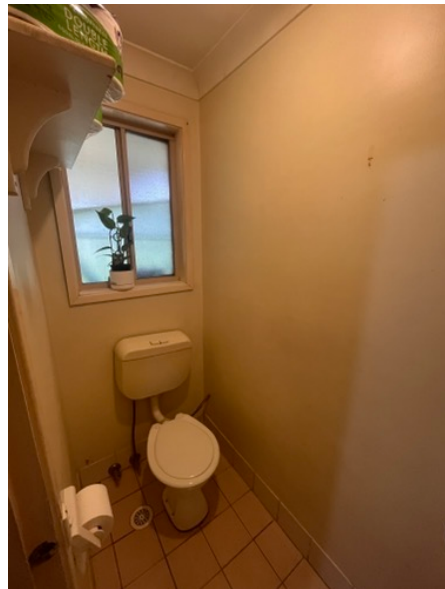
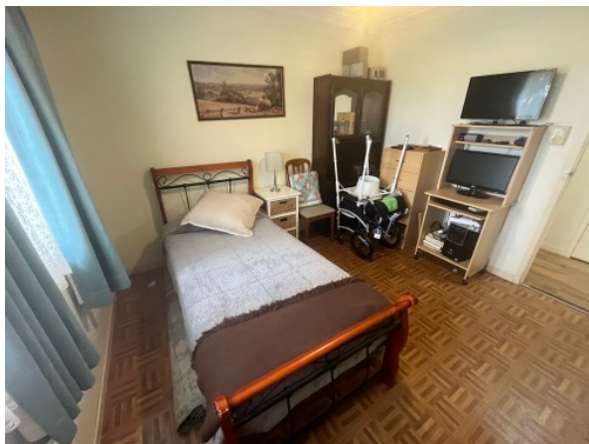
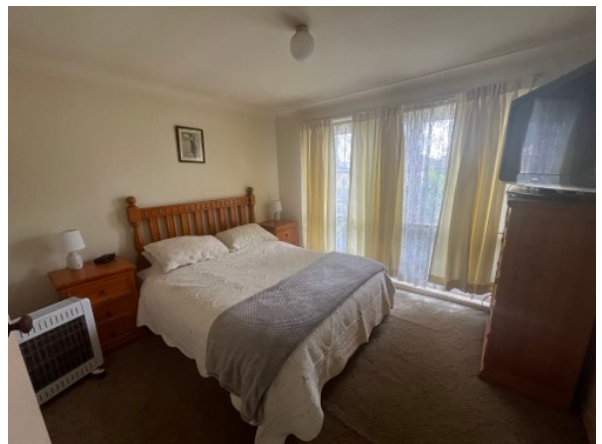
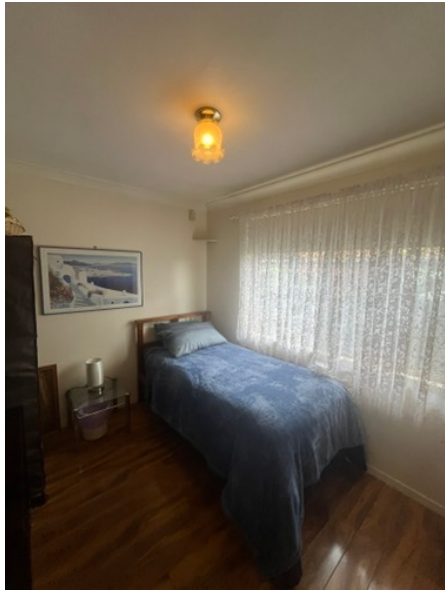
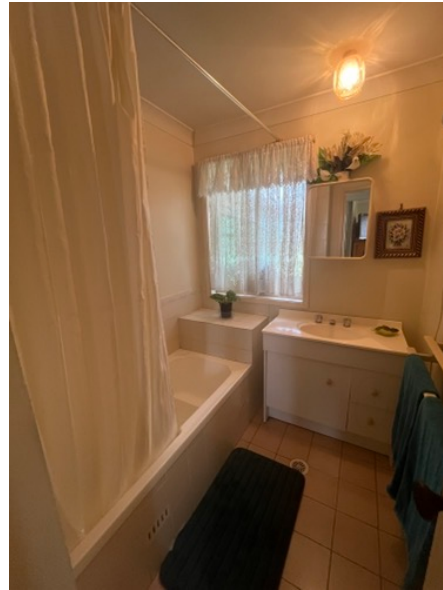
## For your information 2.02

**Location:** All Internal Areas

Upon inspection of the internal areas of the residence, a comprehensive assessment was conducted to identify any visible defects or issues that may impact the dwelling. The inspection encompassed all internal areas, with an evaluation of potential defects such as visible cracks, water damage, and overall structural integrity. Specific attention was given to the condition of walls and floors, as well as the presence of water hammer or any other safety concerns that might compromise the inhabitants' well-being.

It is important to note that if no significant defects are identified during the inspection, regular maintenance and periodic checks are recommended to ensure the continued condition and safety of the property.
