Pre-Inspection Building And Timber Pest Report

Inspection Date: 16 Sep 2025

Property Address: 21/45 Bungarribee Road Blacktown 2148

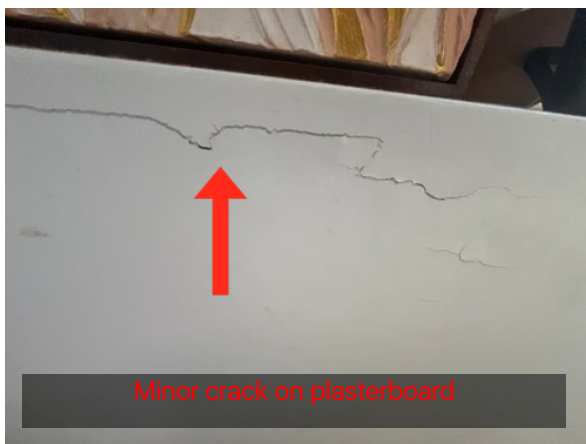
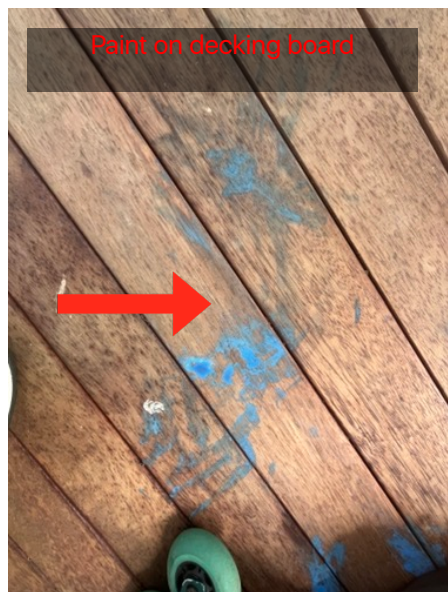
Minor crack on plasterboard

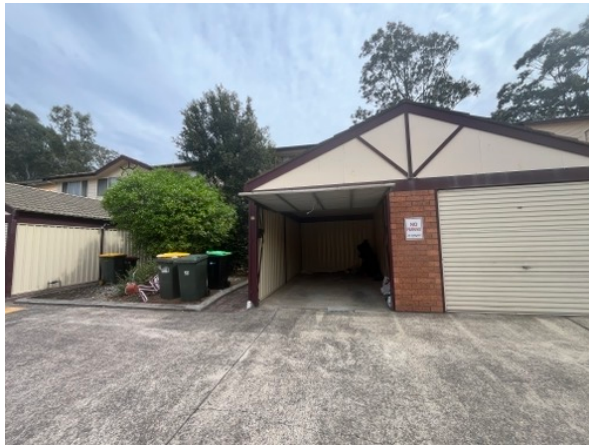
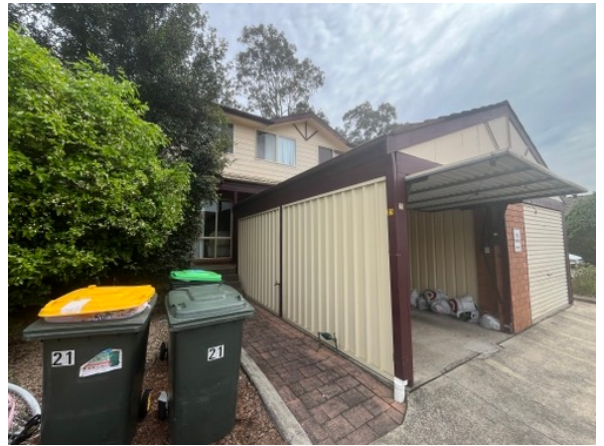
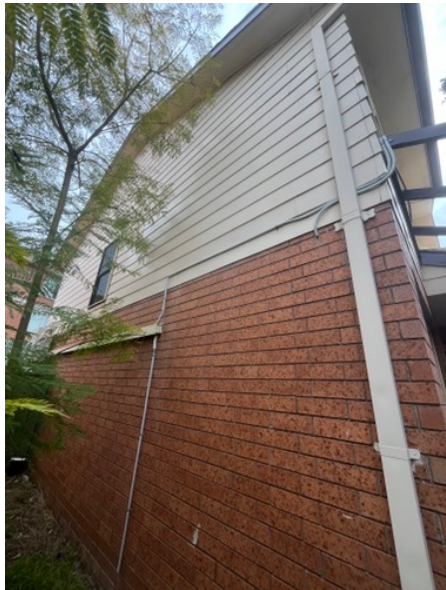
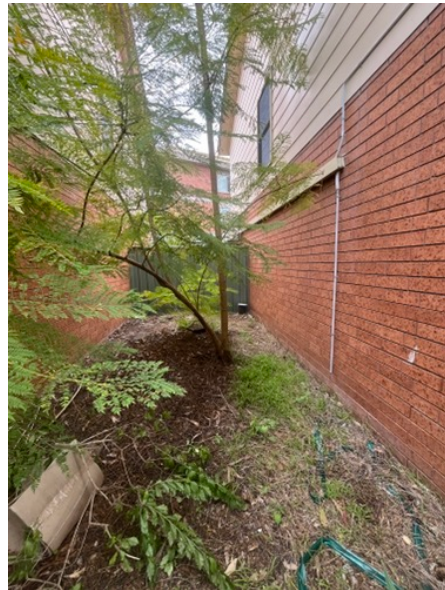
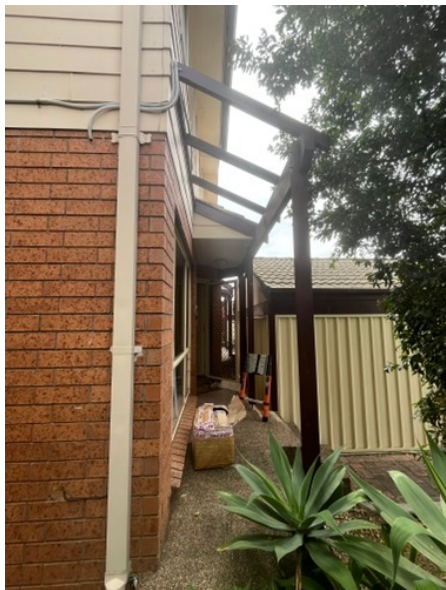
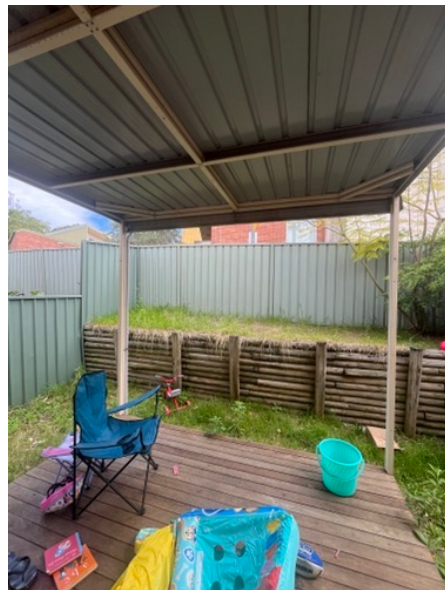
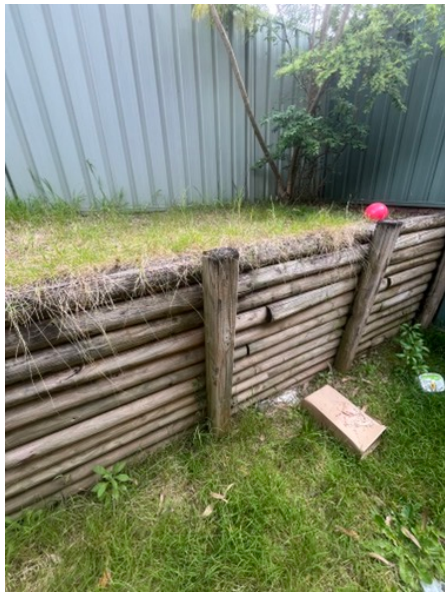
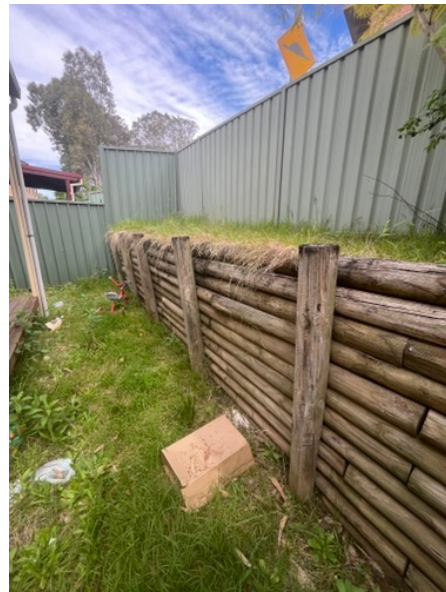
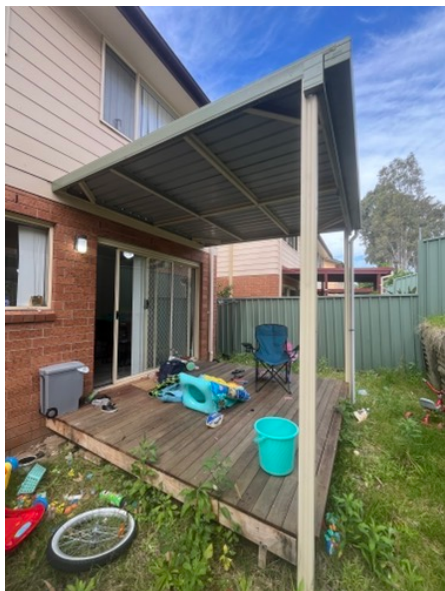
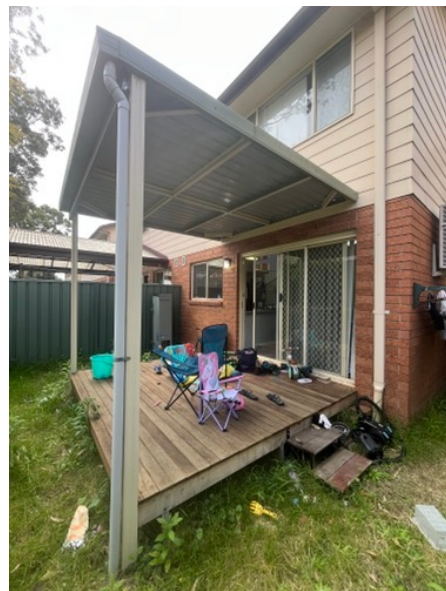
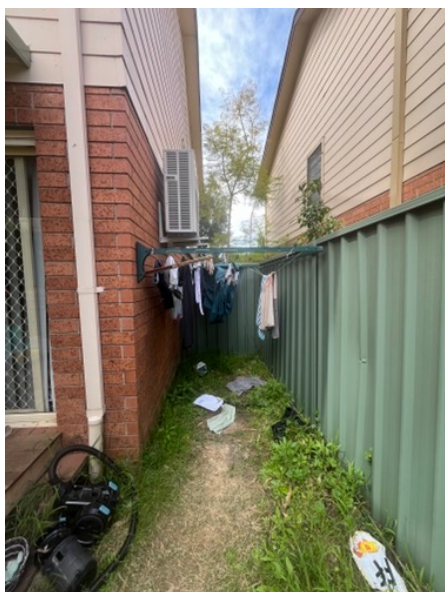
During a comprehensive inspection of the property's external areas conducted at ground level, a thorough assessment of all visible exterior components was performed. The evaluation included the exterior walls, gutters, downpipes, windows, doors, driveway, pathways, fencing, gates, landscaping, and exterior paint finishes. Additionally, whatever could be observed of the roof from the ground level was also examined.

The inspection aimed to identify any apparent minor and major defects affecting the integrity and aesthetic appeal of the property's exterior. As this was a visual inspection, the identification of issues was limited to those areas that were clearly observable and accessible. Any anomalies or imperfections detected during this process will be comprehensively outlined in the subsequent report, thereby equipping prospective buyers with the necessary information to make an informed decision regarding the property's condition and potential need for repairs or maintenance. It is paramount for potential purchasers to carefully review this report to understand all current and potential issues, thereby safeguarding their investment in the property.

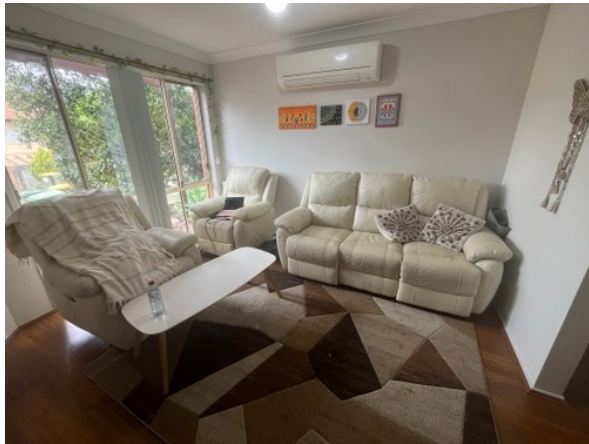
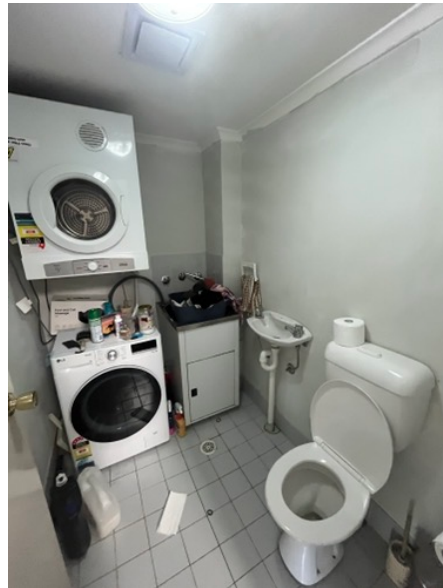
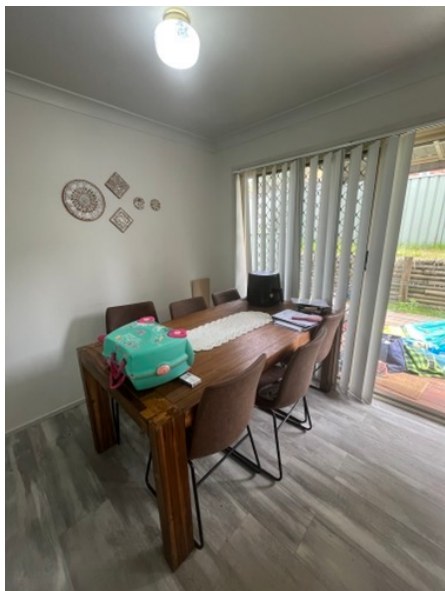
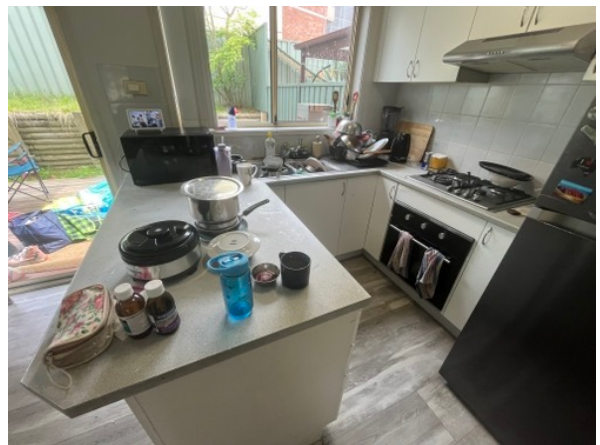
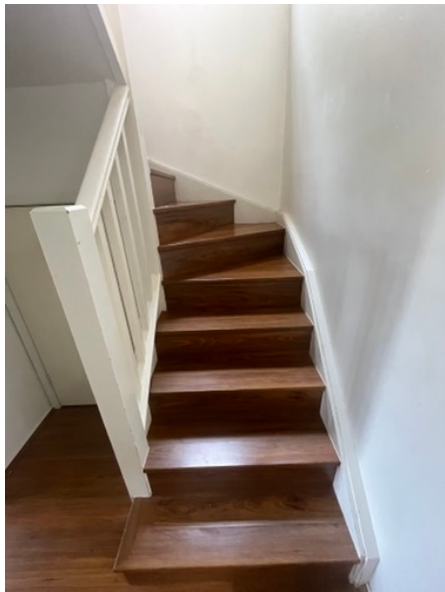
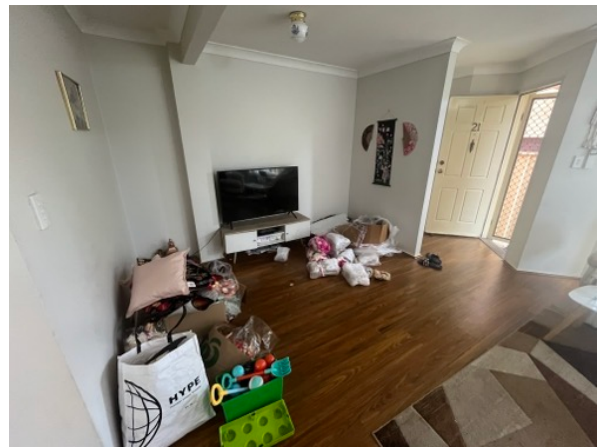
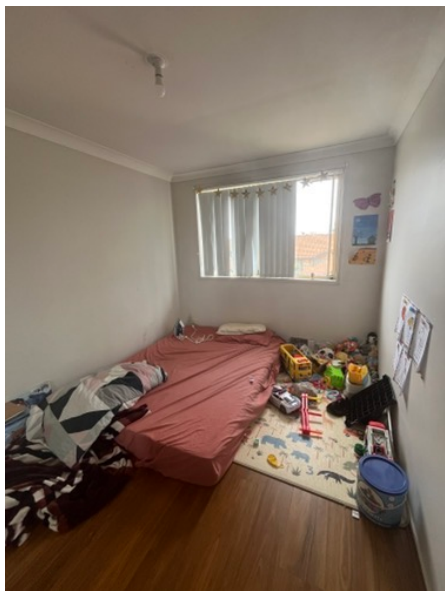
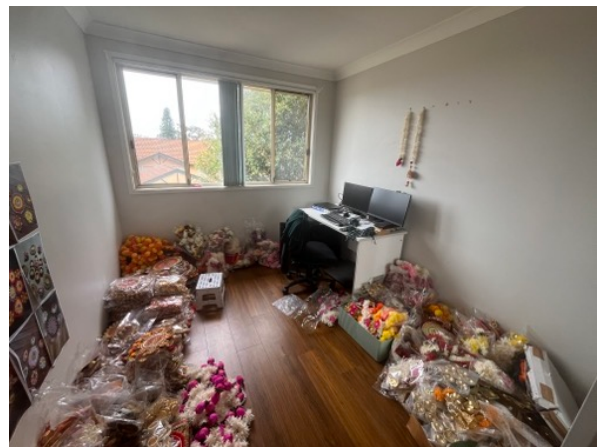
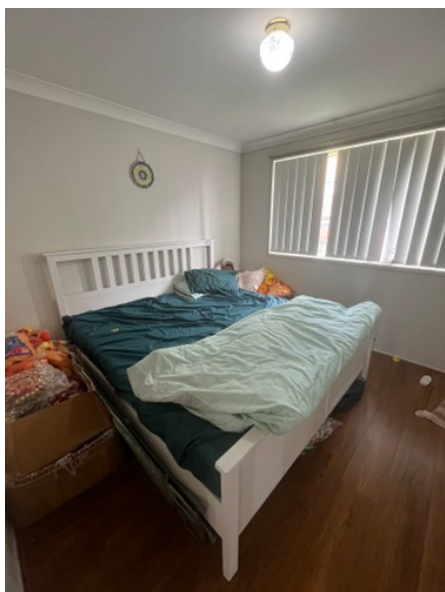
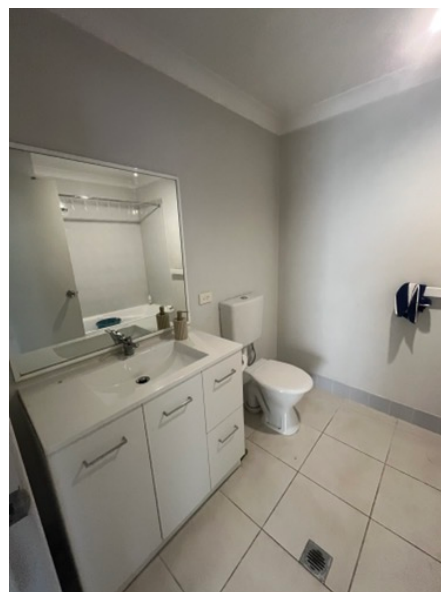
For your information 2.02

Upon inspection of the internal areas of the residence, a comprehensive assessment was conducted to identify any visible defects or issues that may impact the dwelling. The inspection encompassed all internal areas, with an evaluation of potential defects such as visible cracks, water damage, and overall structural integrity. Specific attention was given to the condition of walls and floors, as well as the presence of water hammer or any other safety concerns that might compromise the inhabitants' well-being.

It is important to note that if no significant defects are identified during the inspection, regular maintenance and periodic checks are recommended to ensure the continued condition and safety of the property.
