# Pre Inspection Building And Timber Pest Report

**Inspection Date: 13 Oct 2025**

Property Address: 20 Bandicoot Drive Woodcroft 2767

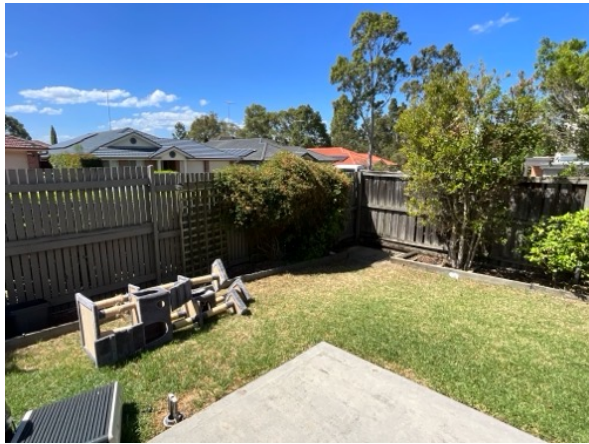
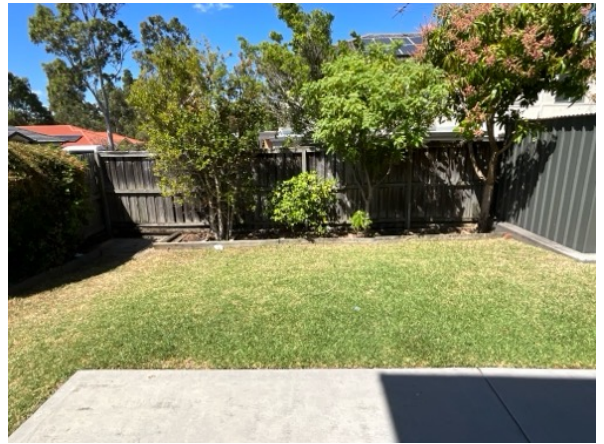
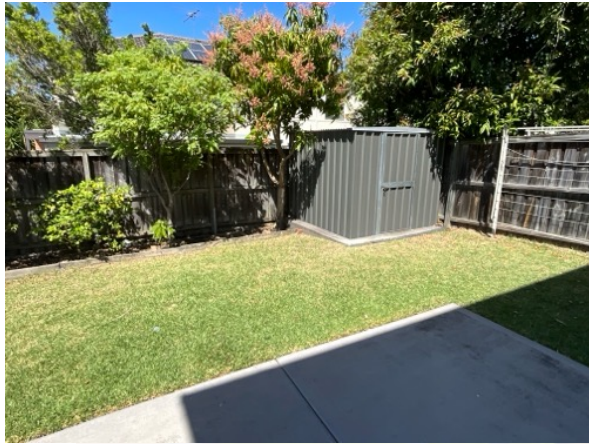
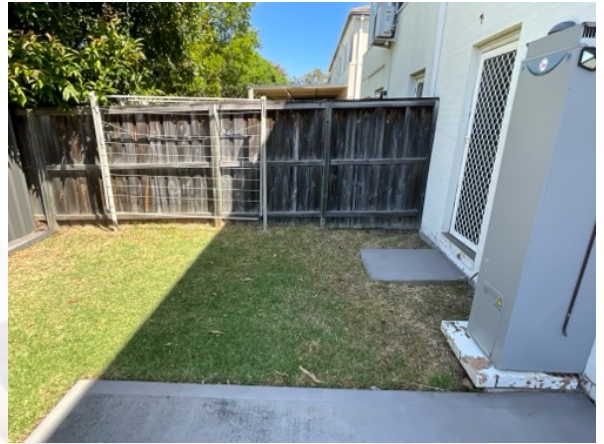
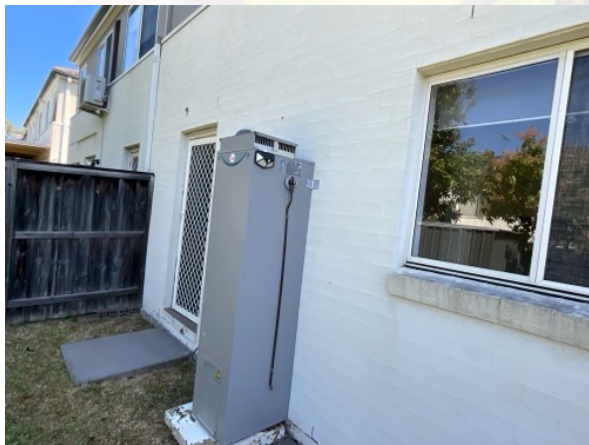
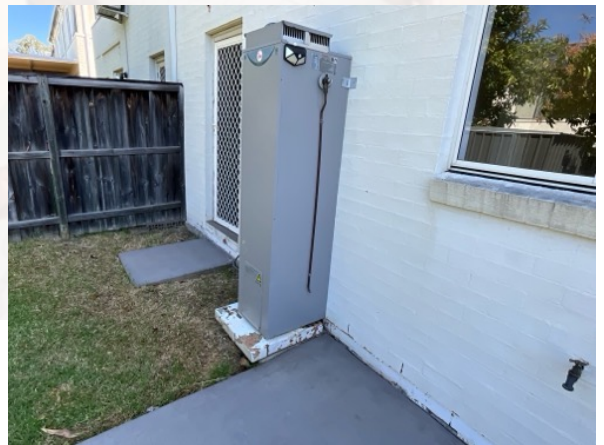
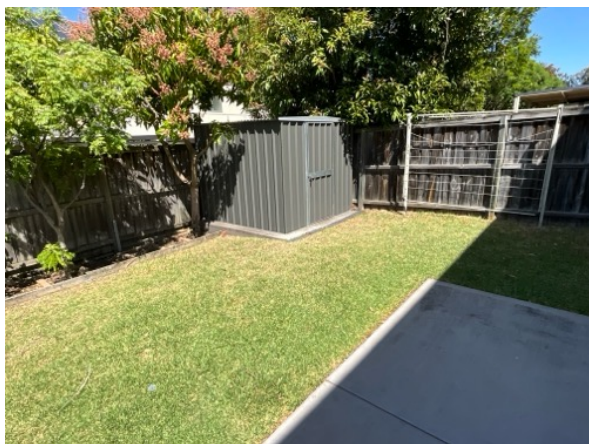
7. **Landscaping:**The landscaping around the property was reviewed, and no specific concerns were noted. However, routine landscaping maintenance is advised to keep the property's appearance appealing.

8. **Exterior Paint and Finishes:**The exterior paint and finishes were assessed for signs of peeling, cracking, or fading. The property's facade was generally well-maintained.

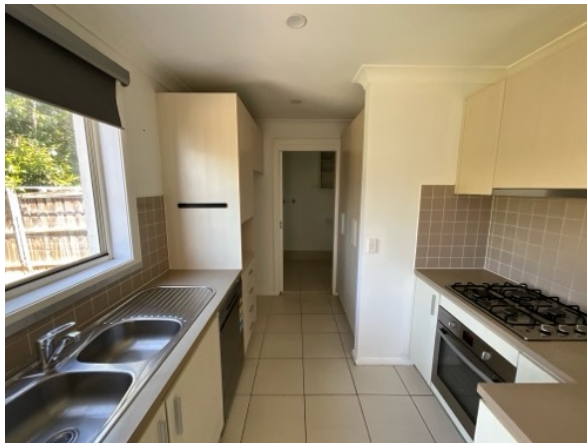
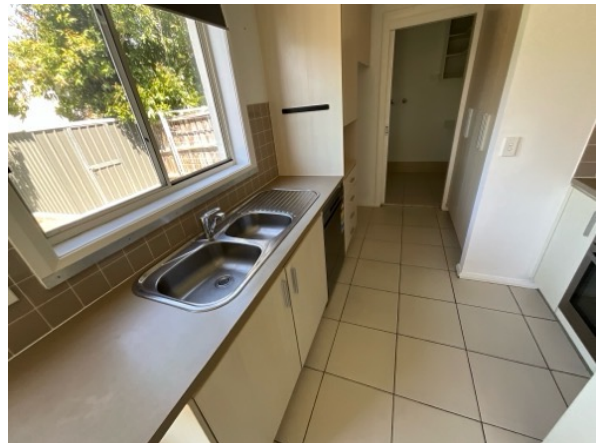
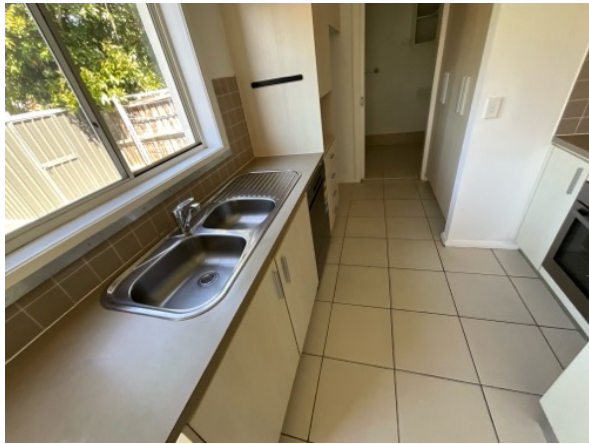
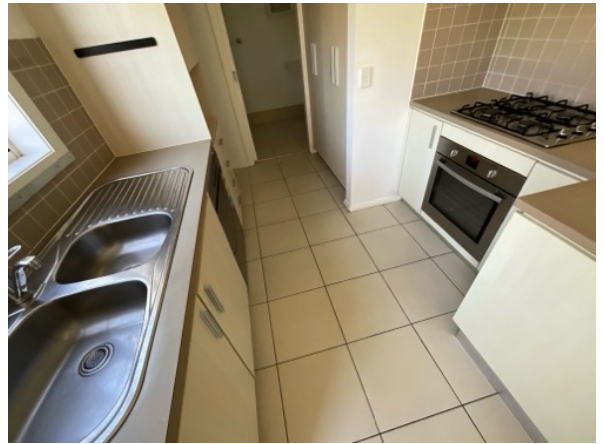
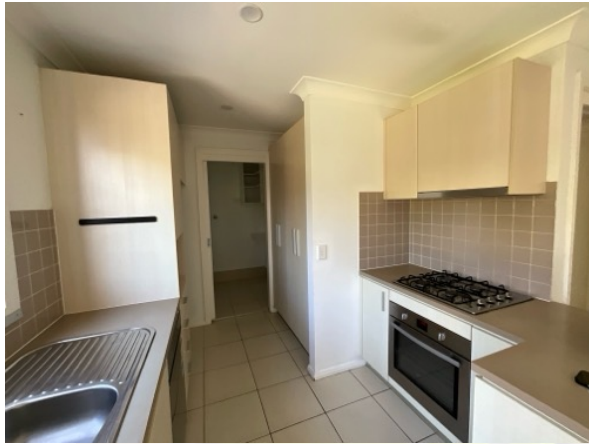
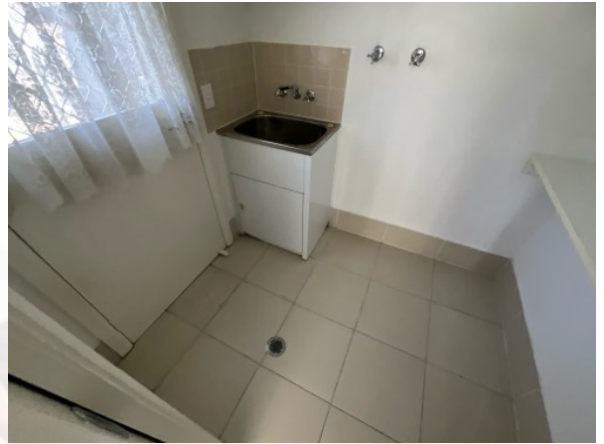
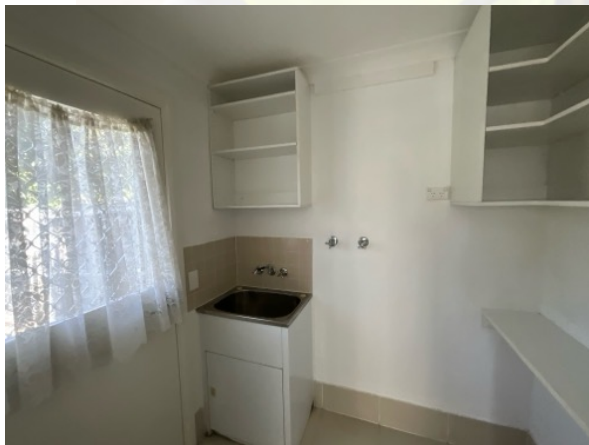
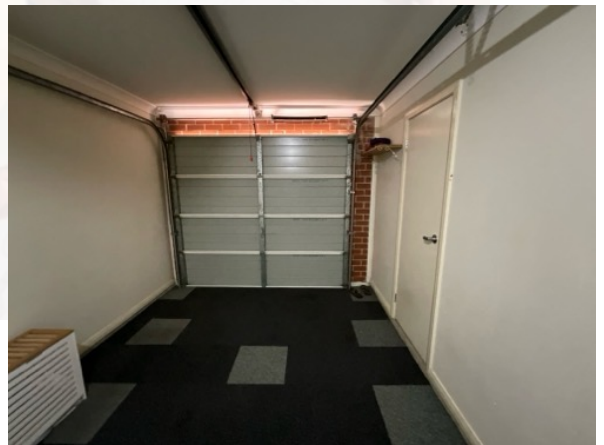
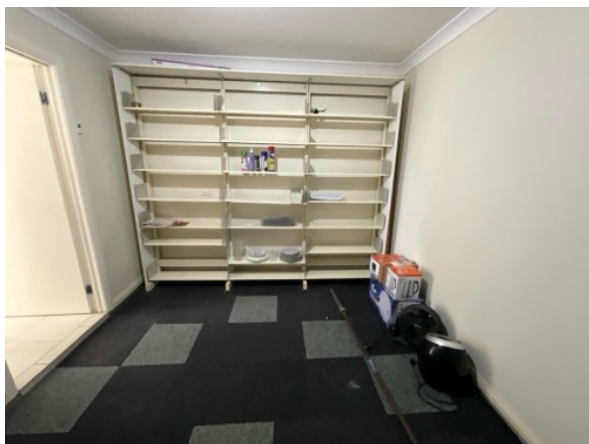
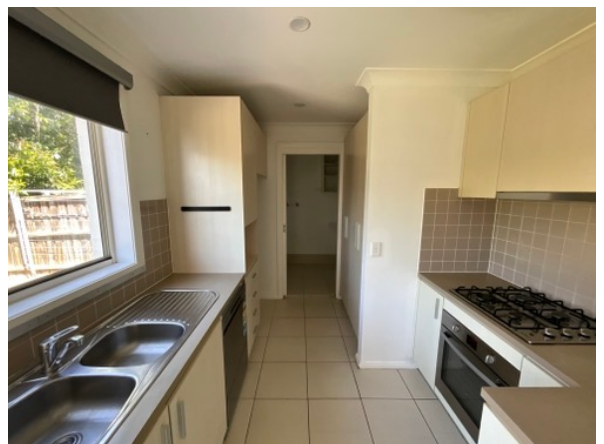
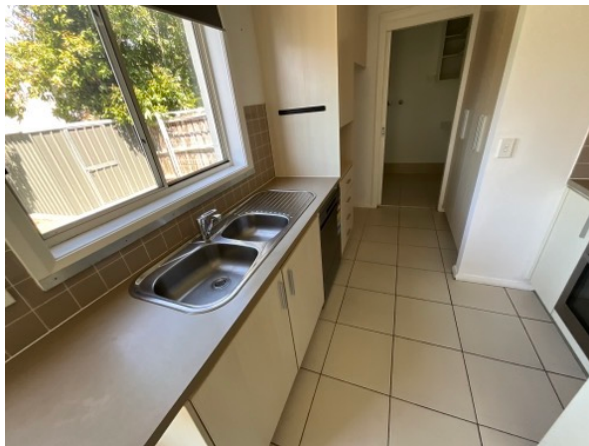
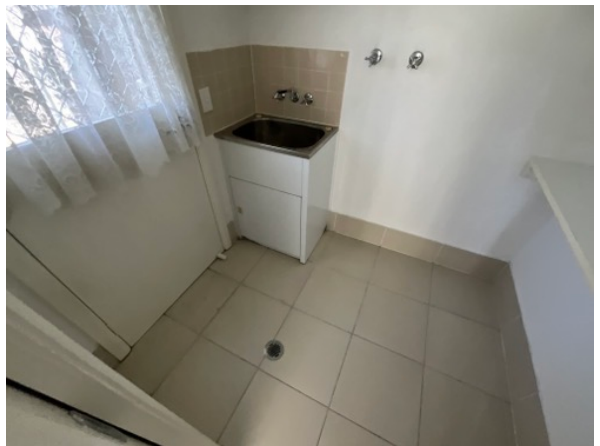
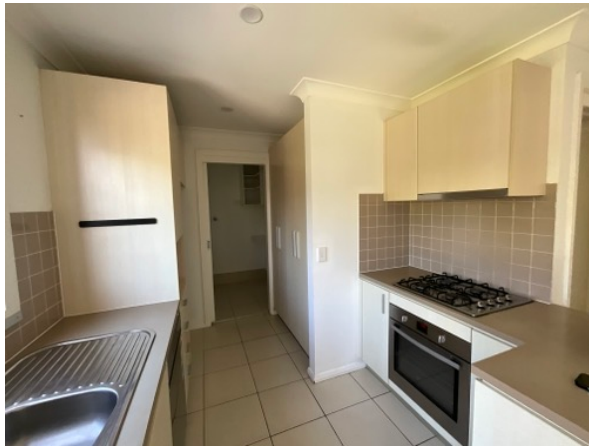
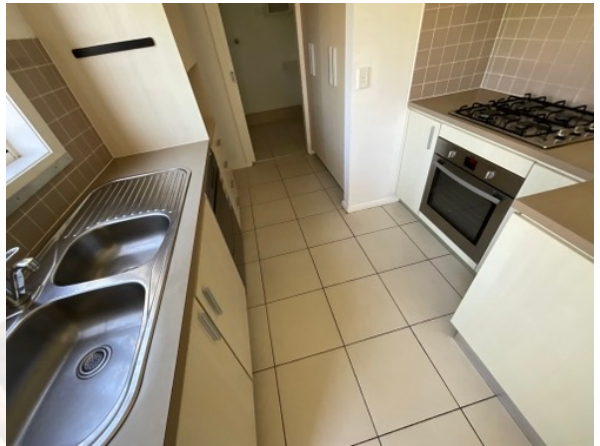
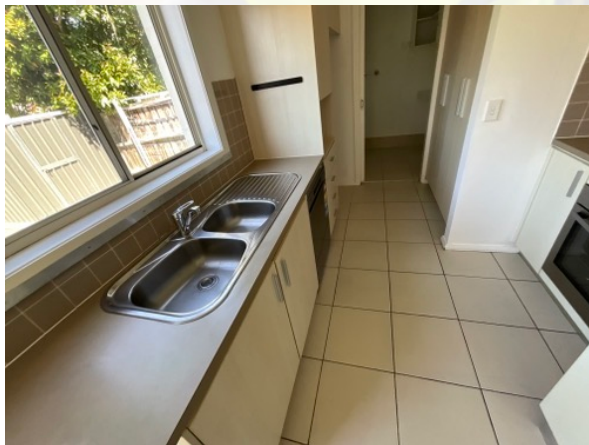
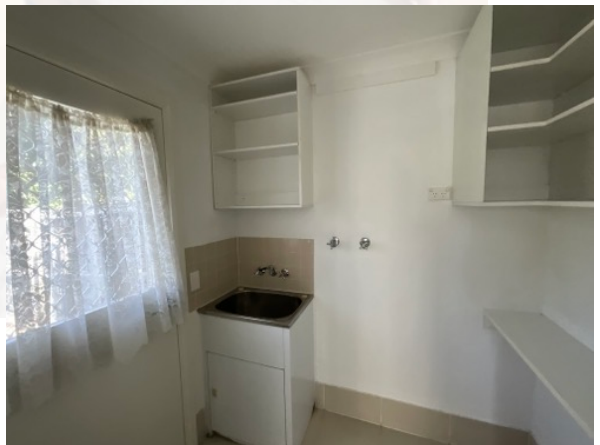
**Location:** All Internal Areas

7. Ceilings and Walls: Ceilings and walls were examined for any signs of water damage, cracks, or structural concerns, and no major issues were found.

It is important to note that while no significant defects were identified during the inspection, regular maintenance and periodic checks are recommended to ensure the continued condition and safety of the property.

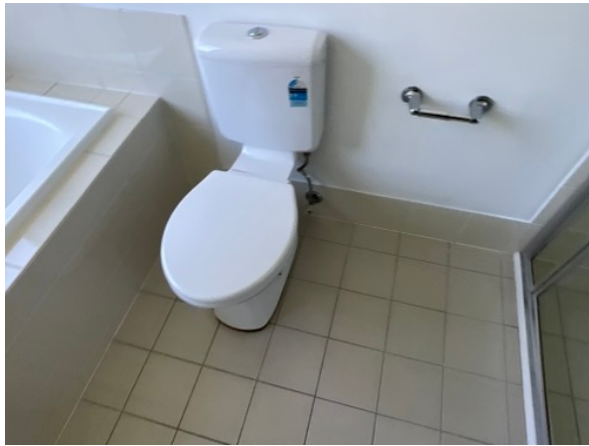
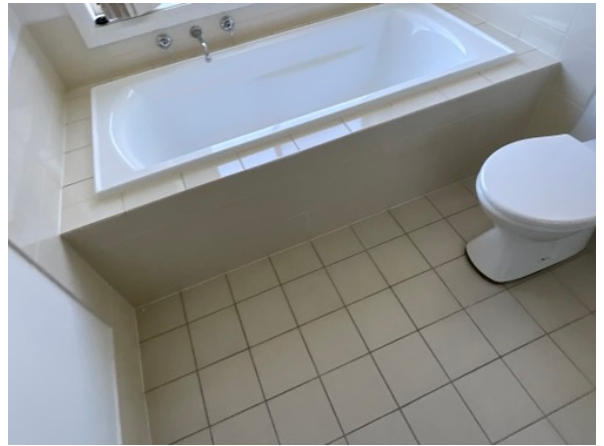
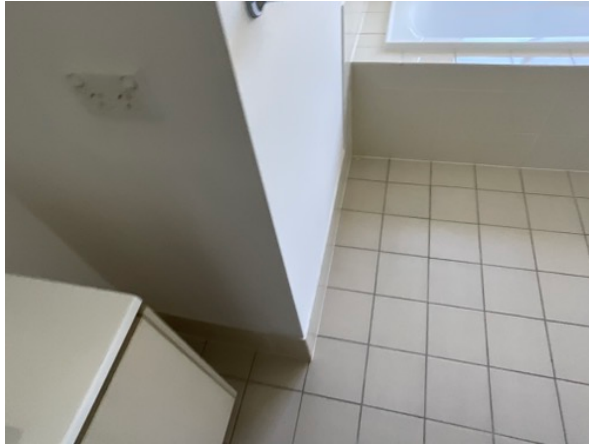
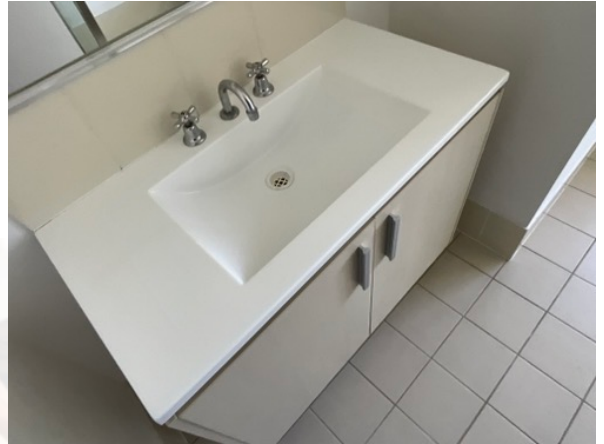
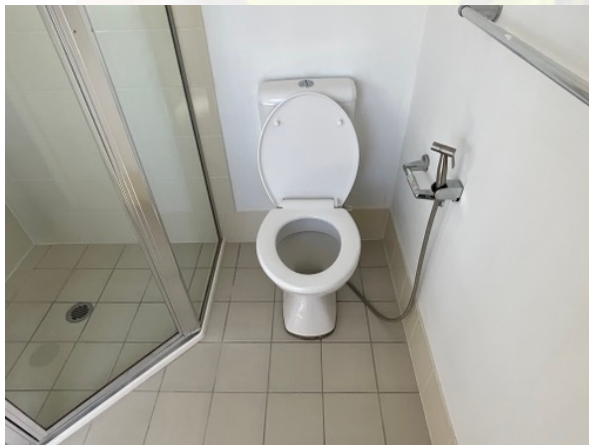
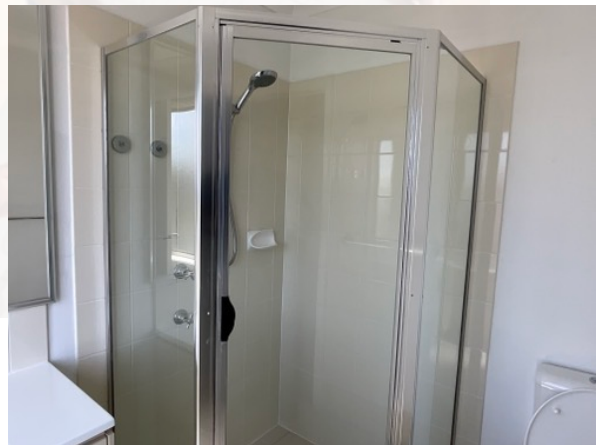
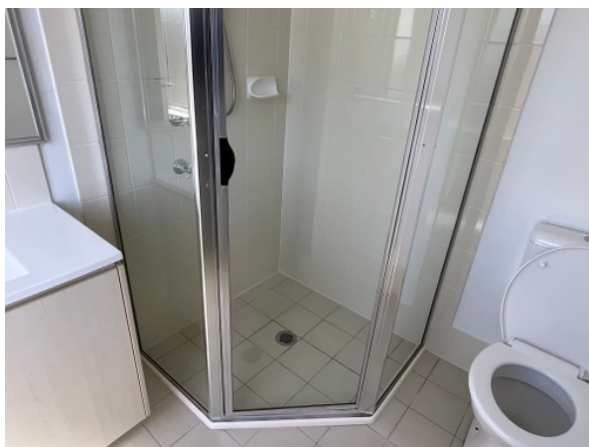
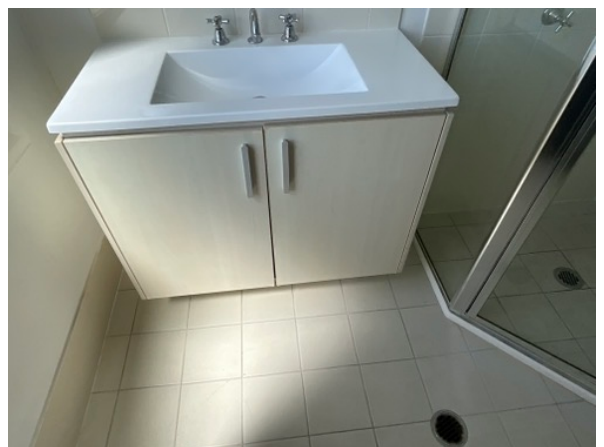
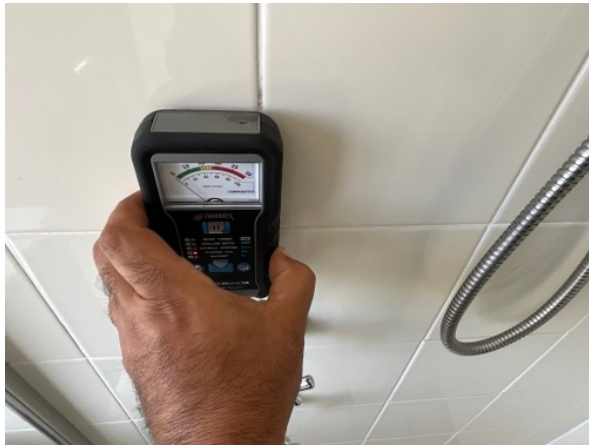
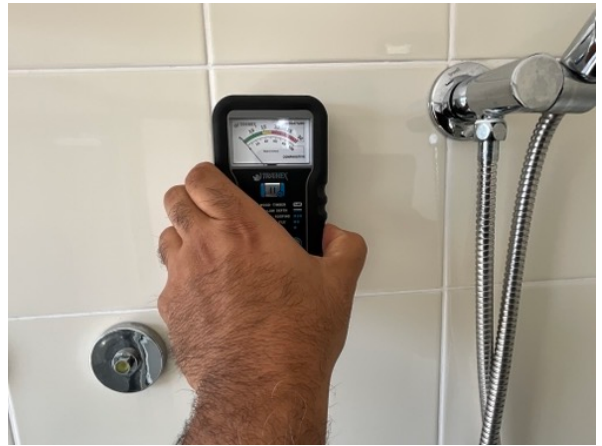
**Location:** Bathrooms

It is important to note that low moisture readings in bathrooms are positive indicators, suggesting that there are no immediate water-related problems. However, regular maintenance and monitoring of these areas are still recommended to prevent potential issues in the future.
