# Pre Inspection Building And Timber Pest Report

**Inspection Date: 10 Oct 2025**

Property Address: 4 Silvereye Circuit Woodcroft 2767

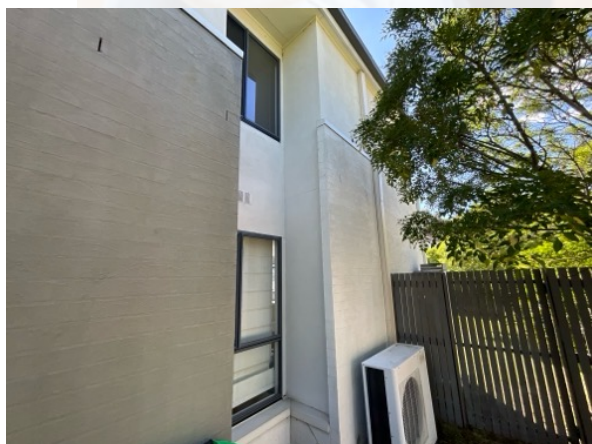
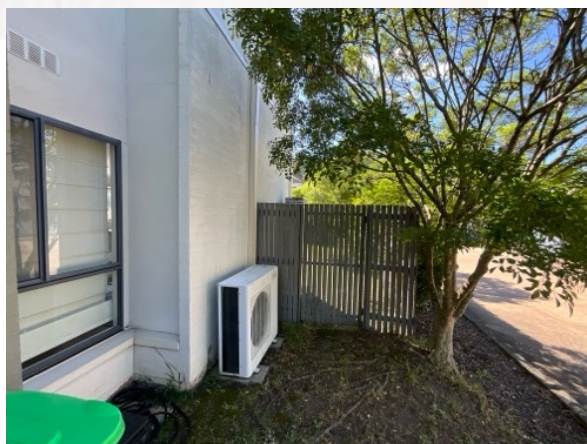
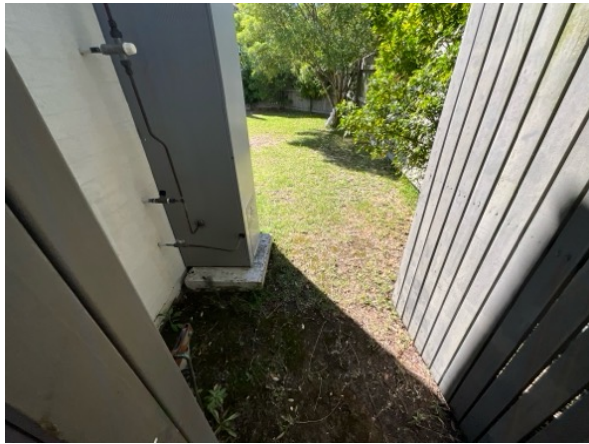
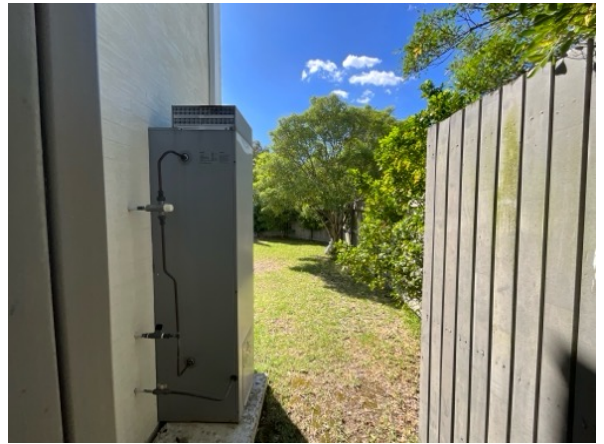
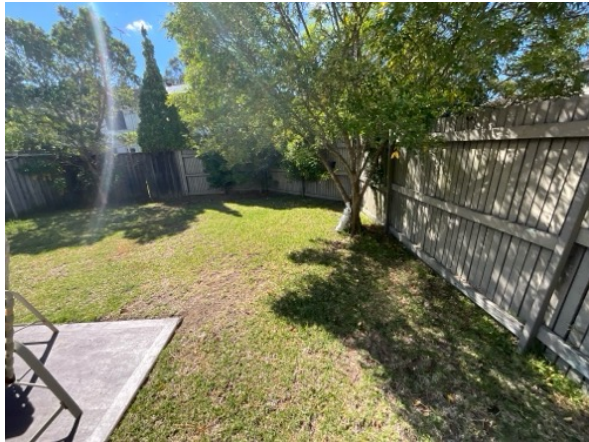
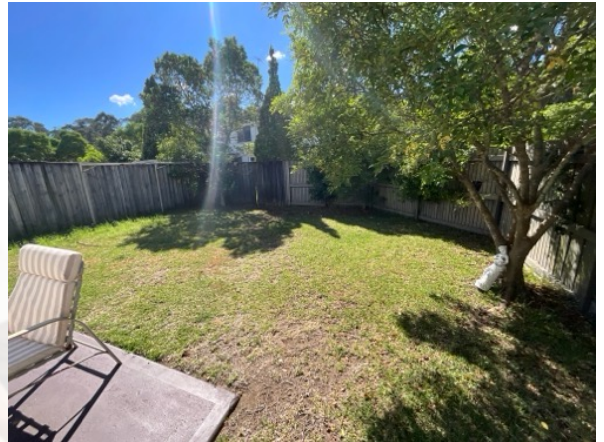
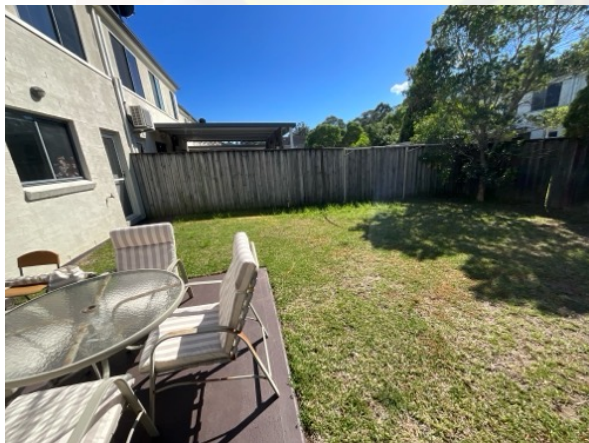
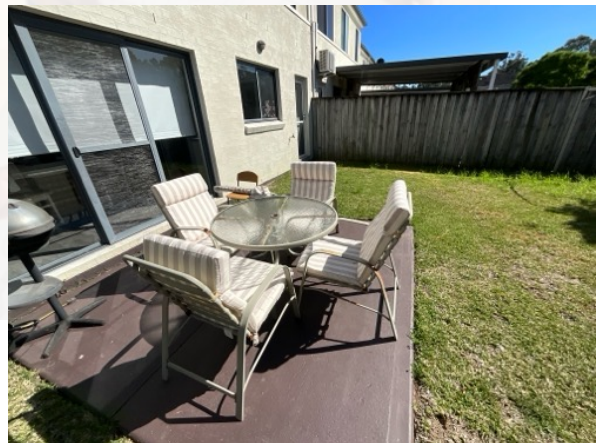
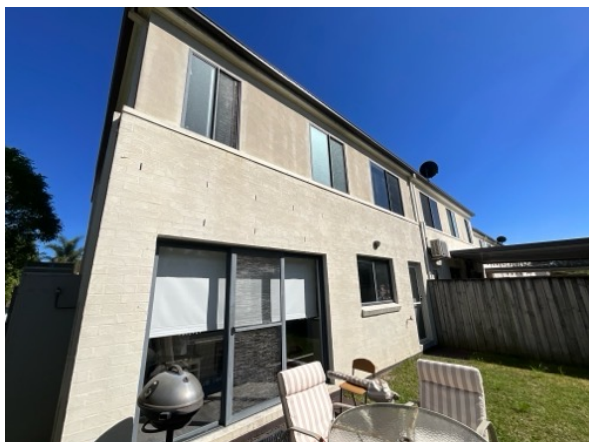
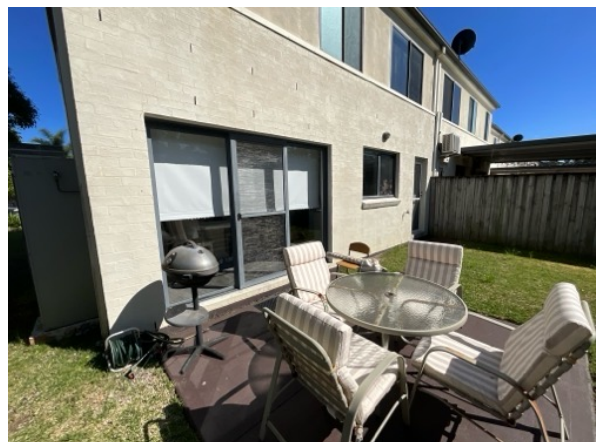
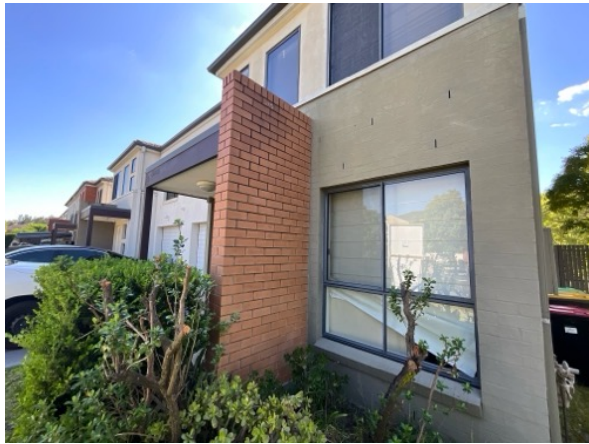
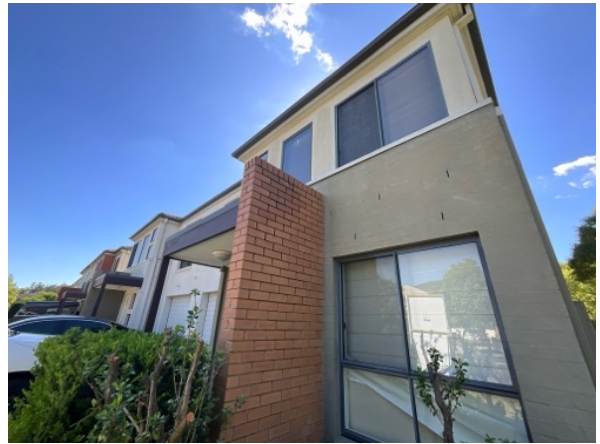
**Landscaping:**The landscaping around the property was reviewed, and no specific concerns were noted. However, routine landscaping maintenance is advised to keep the property's appearance appealing.

**Exterior Paint and Finishes:**The exterior paint and finishes were assessed for signs of peeling, cracking, or fading. The property's facade was generally well-maintained.

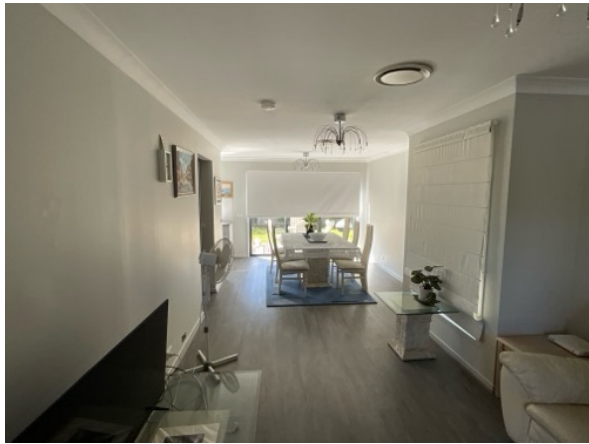
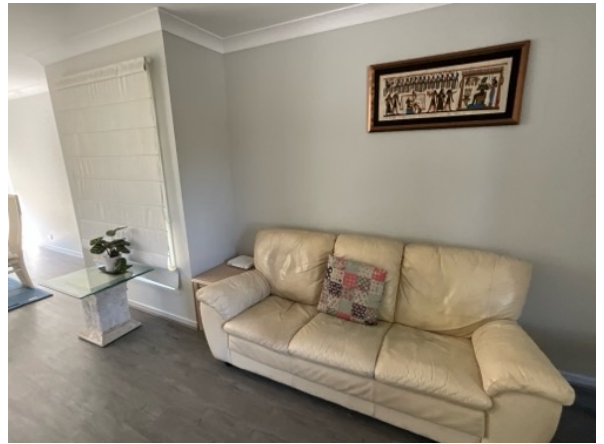
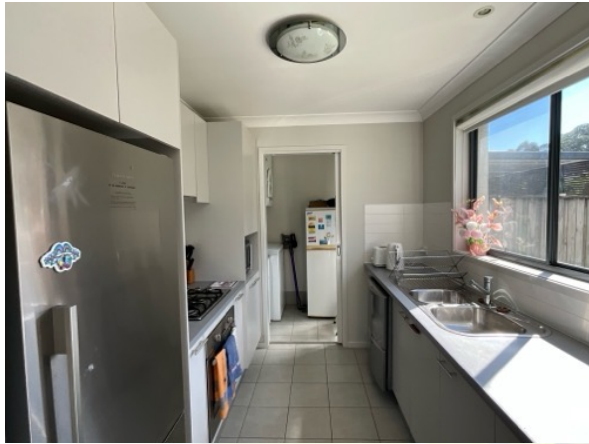
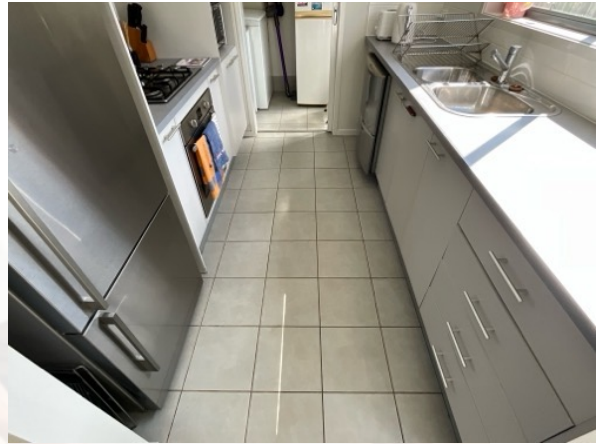
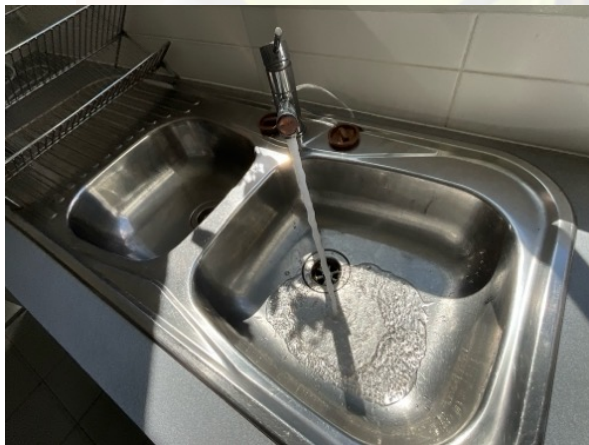
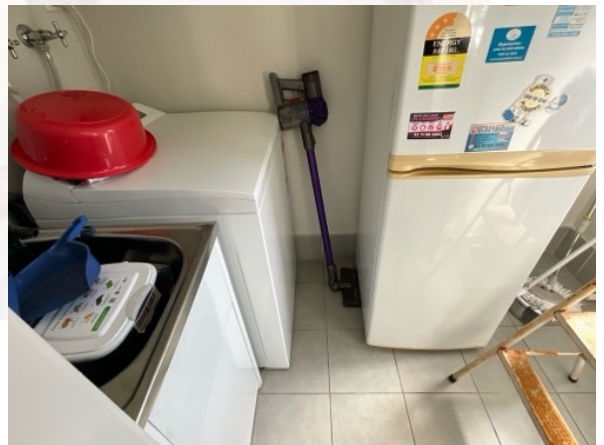
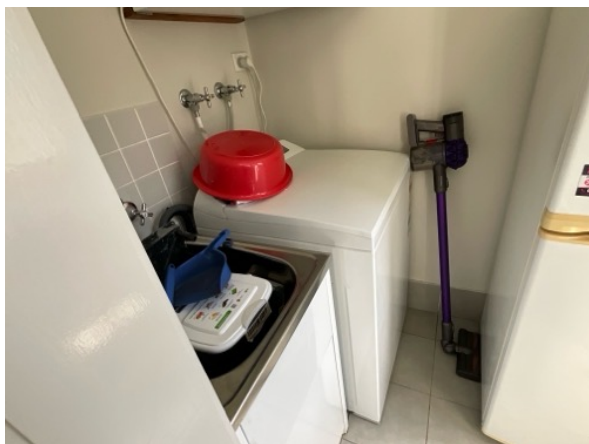
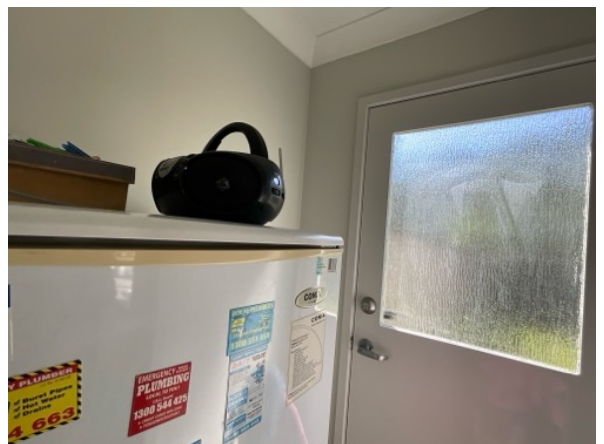
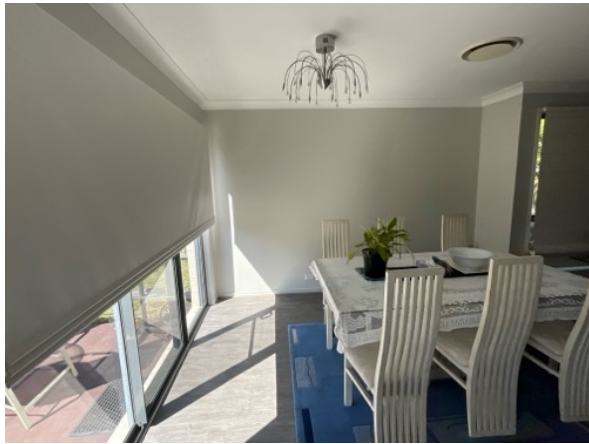
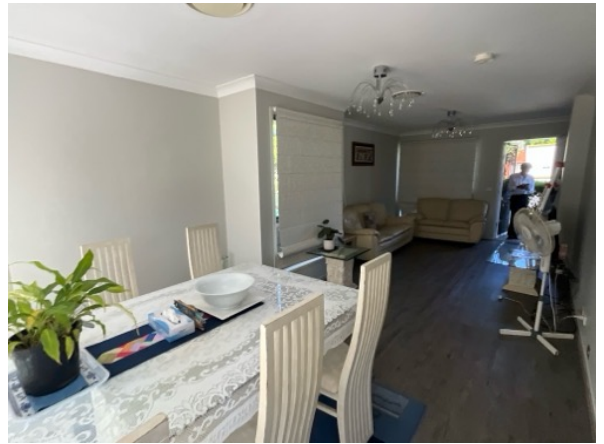
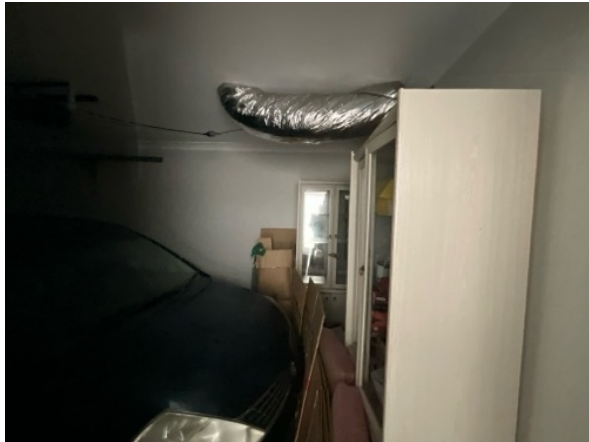
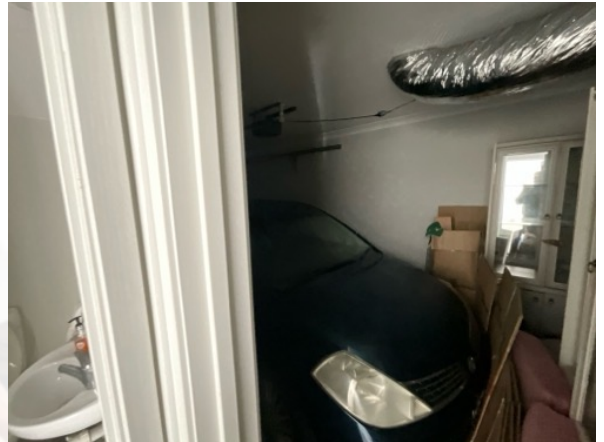
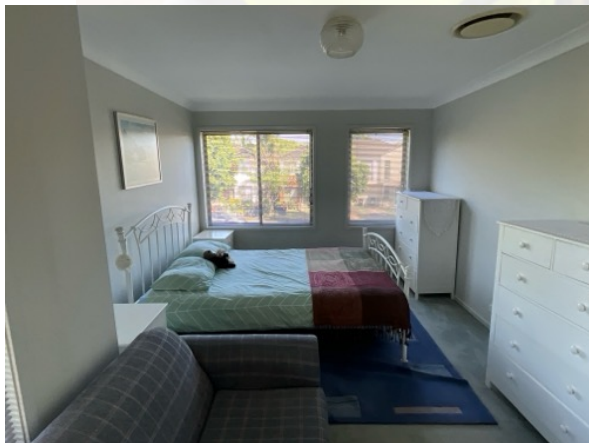
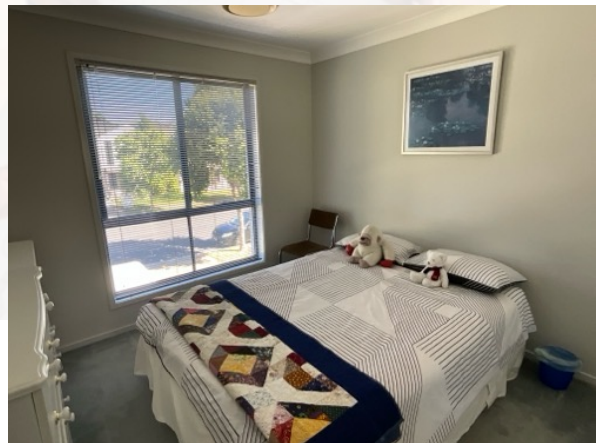
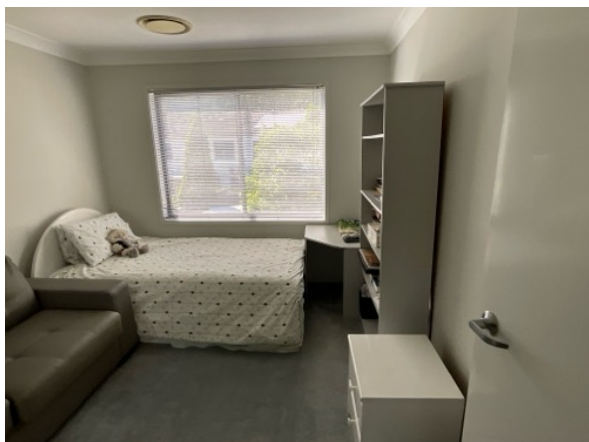
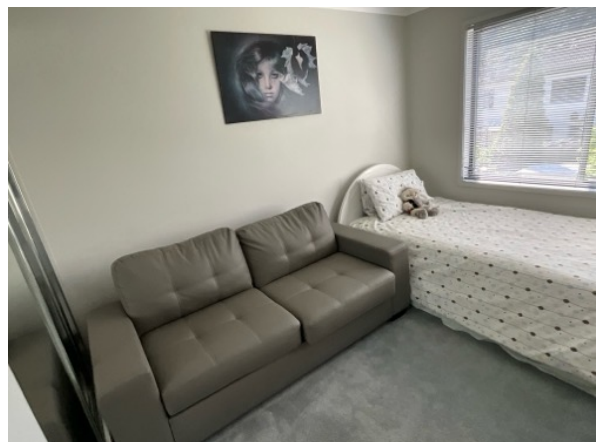
## For your information 2.02

**Location:** All Internal Areas

6. Flooring and Carpets: The flooring and carpets throughout the property were generally well-maintained and free from visible damages.
7. Ceilings and Walls: Ceilings and walls were examined for any signs of water damage, cracks, or structural concerns, and no major issues were found.

It is important to note that while no significant defects were identified during the inspection, regular maintenance and periodic checks are recommended to ensure the continued condition and safety of the property.

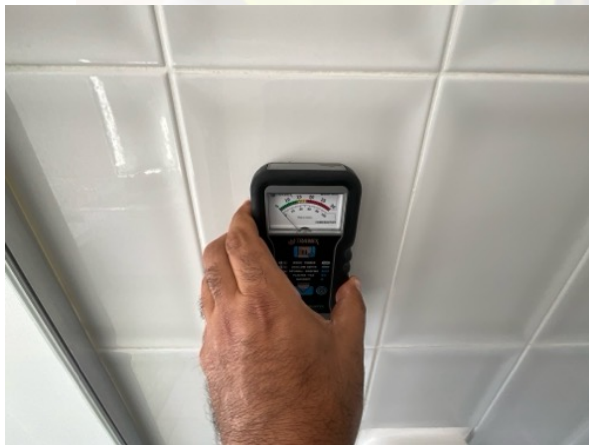
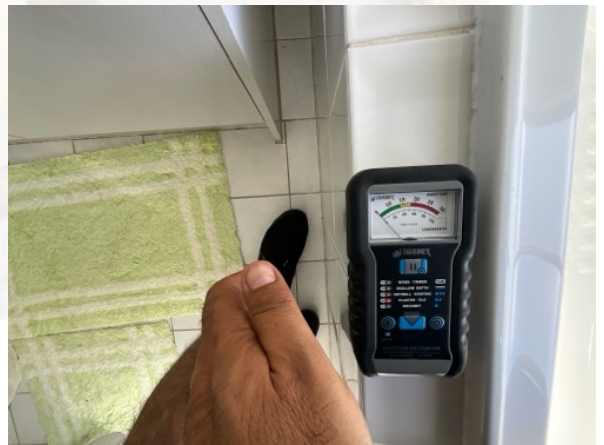
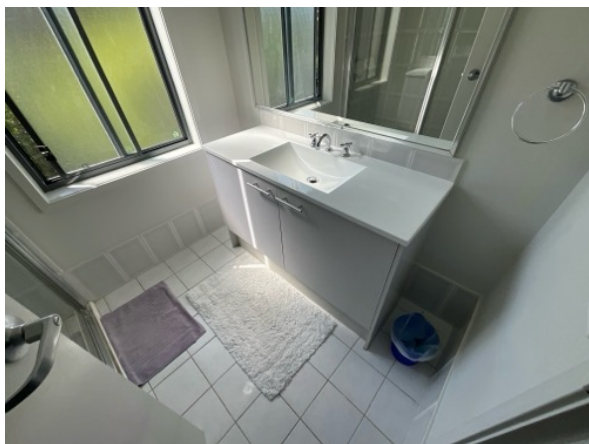
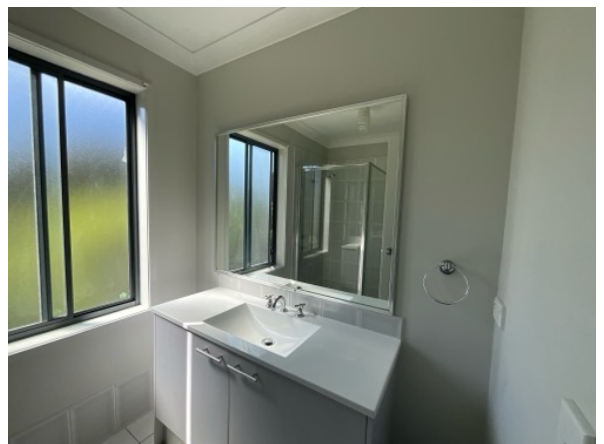
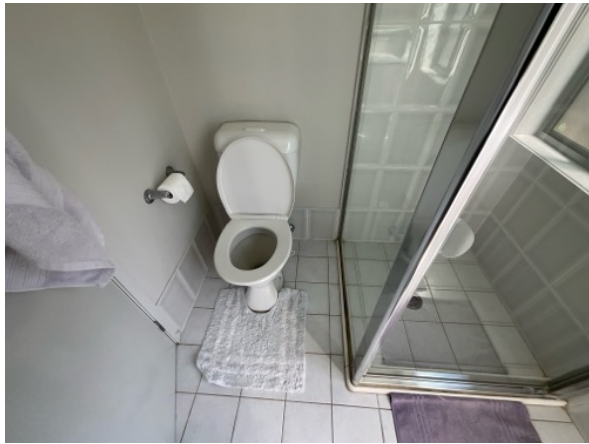
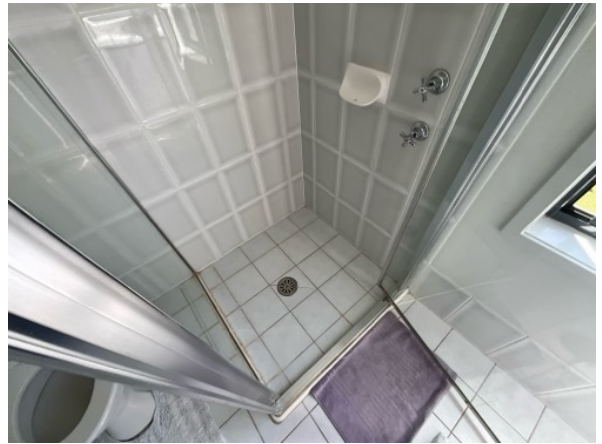
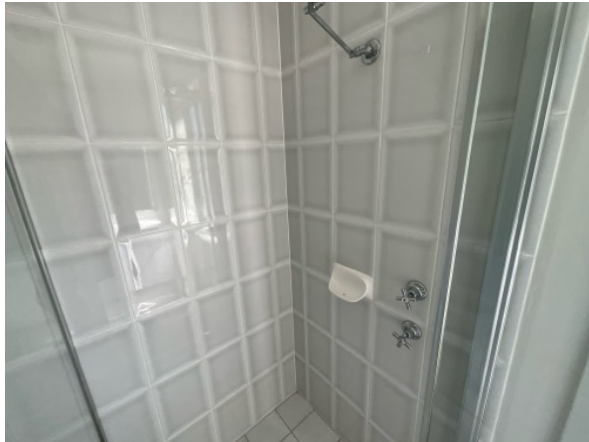
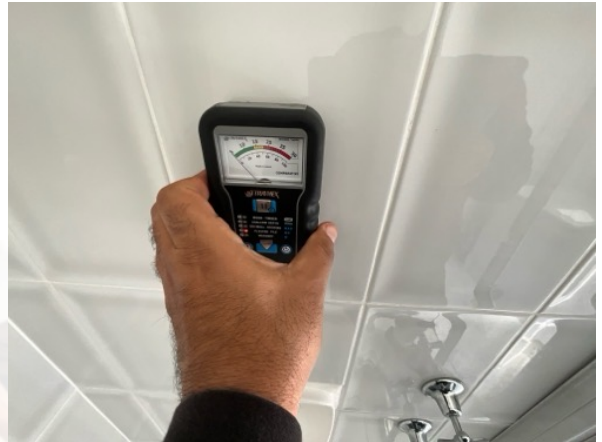
## For your information 2.03

**Location:** Bathrooms

**Finding:** Additional Photos-low moisture readings

It is important to note that low moisture readings in bathrooms are positive indicators, suggesting that there are no immediate water-related problems. However, regular maintenance and monitoring of these areas are still recommended to prevent potential issues in the future.

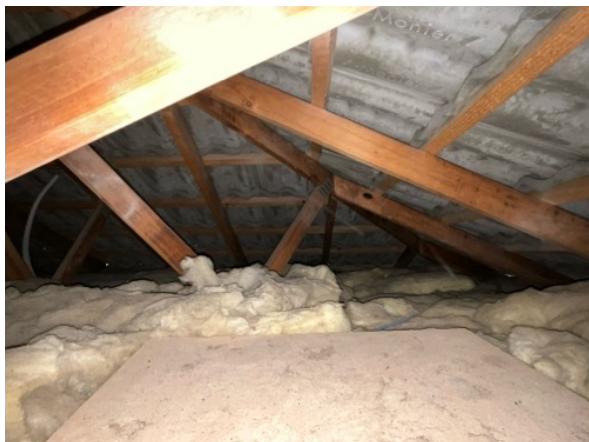
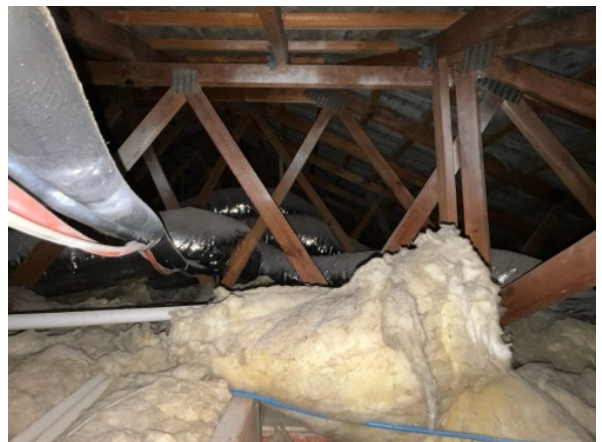
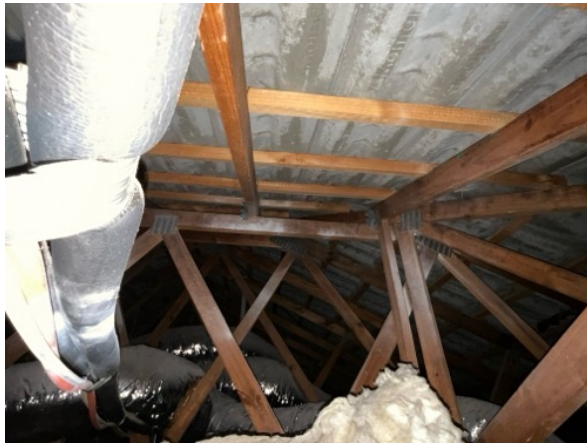
Note/Description: The installation of proper insulation and sarking is a positive aspect of the property. This helps in maintaining temperature control, reducing energy consumption, and preventing moisture penetration. Buyers should be aware that this installation contributes to the overall energy efficiency and comfort of the building.

Recommendations: No further actions are required in relation to this observation, as the correct installation of insulation and sarking aligns with recommended building practices. This contributes to the property's compliance with energy efficiency standards and enhances its overall value.
