# Pre Inspection Building And Timber Pest Report

**Inspection Date: 5 Nov 2025**

Property Address: 38 Burragorang Street Woodcroft 2767

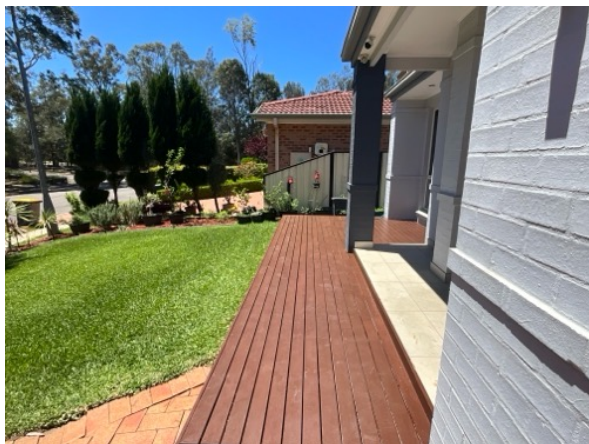
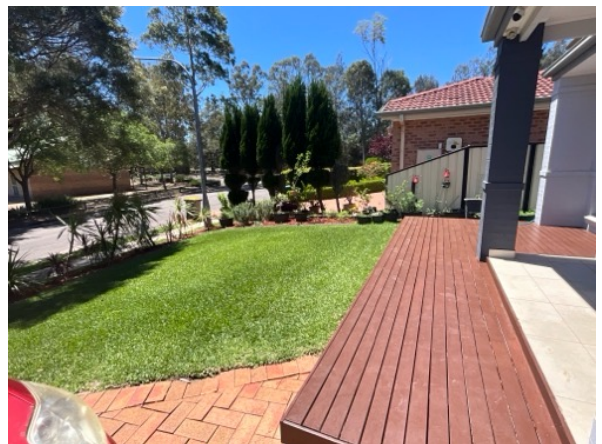
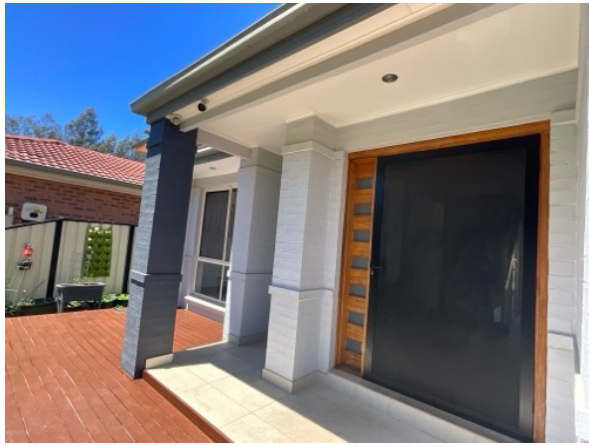
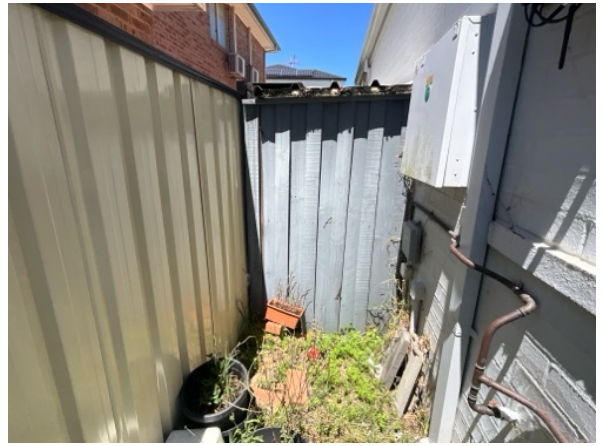
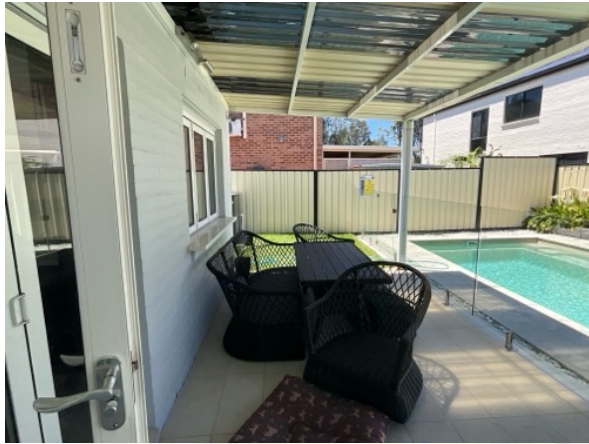
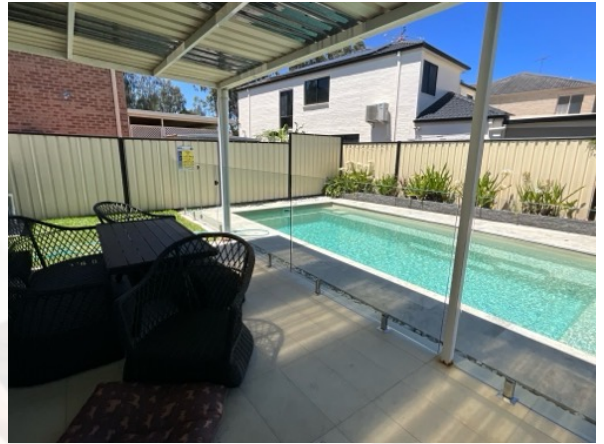
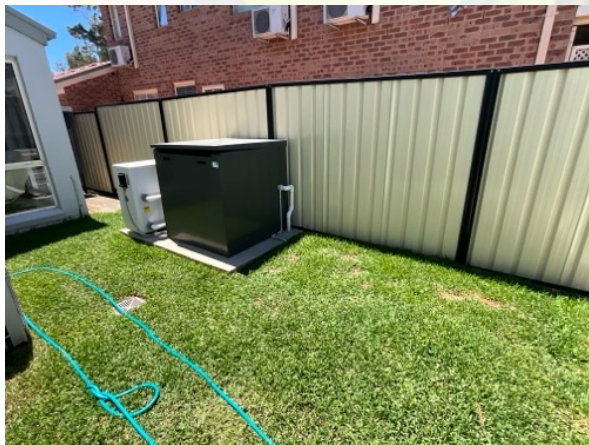
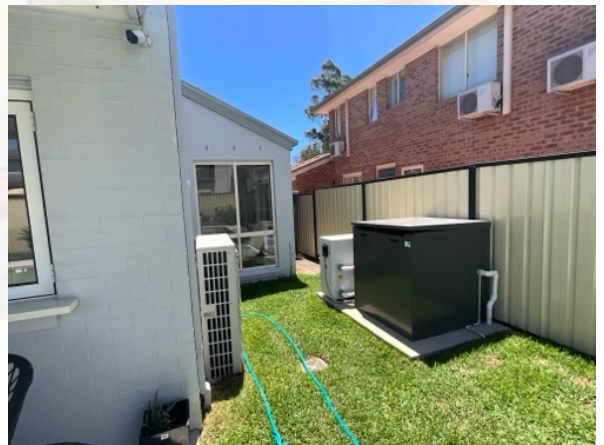
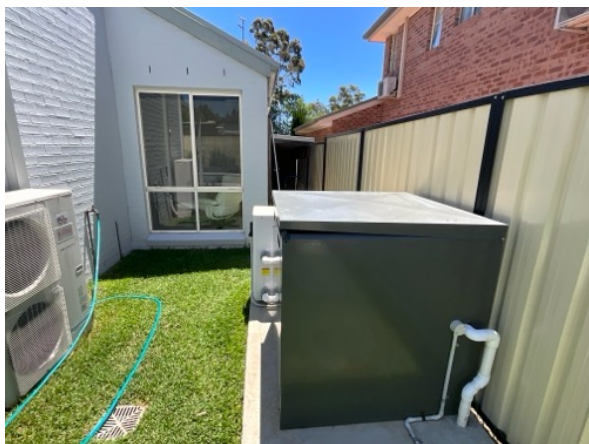
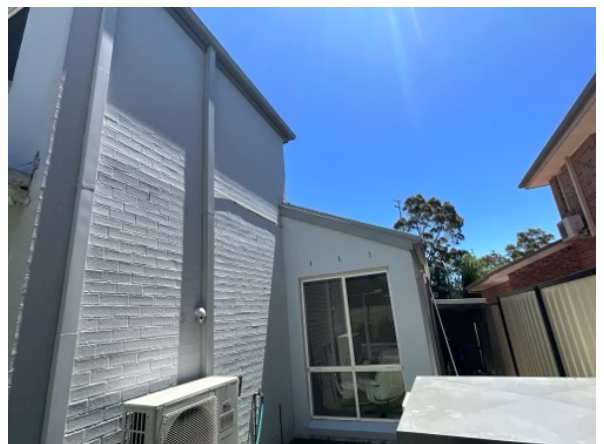
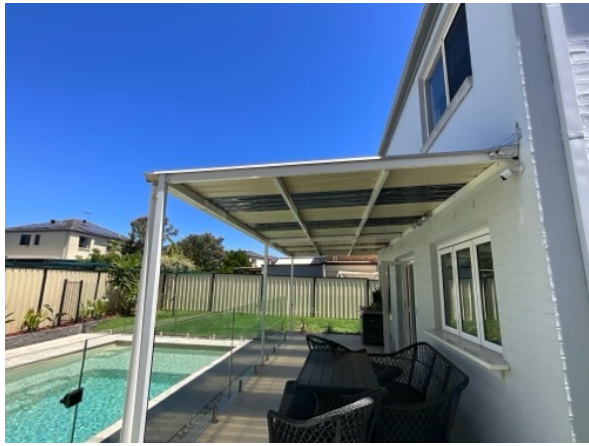
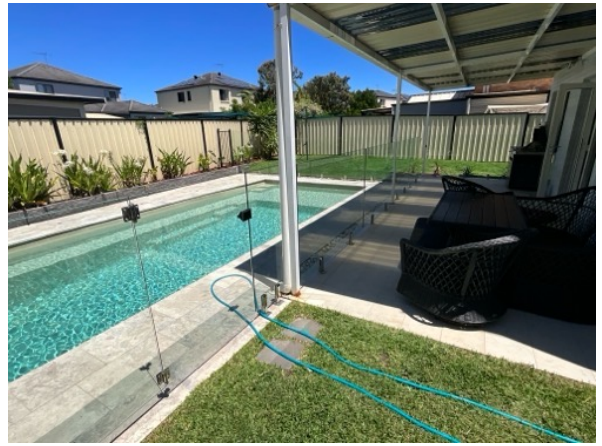
**Landscaping:**The landscaping around the property was reviewed, and no specific concerns were noted. However, routine landscaping maintenance is advised to keep the property's appearance appealing.

**Exterior Paint and Finishes:**The exterior paint and finishes were assessed for signs of peeling, cracking, or fading. The property's facade was generally well-maintained.
