10 Year Strata Maintenance Plan

1 Harper terrace South Perth

Client Name : The Owners Strata Plan 70215
Report Number : 9870
Inspection Date : Friday 28th May -18 June 2021
Weather Conditions : Fine
Inspected by : Brian Connor B.App.Sc
Registered Builder 100541
Member of Building Inspectors association of WA

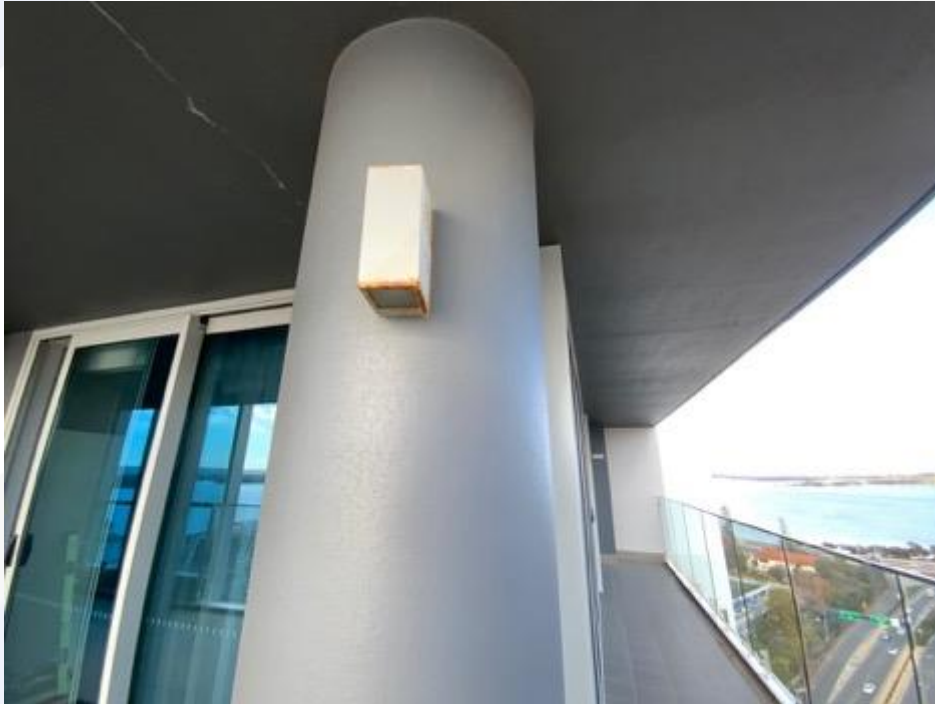
6. White efflorescence visible through hairline crack through upper balcony soffit
7. Hairline crack through upper balcony soffit on north elevation efflorescence occurring 1 m east of corner glazing

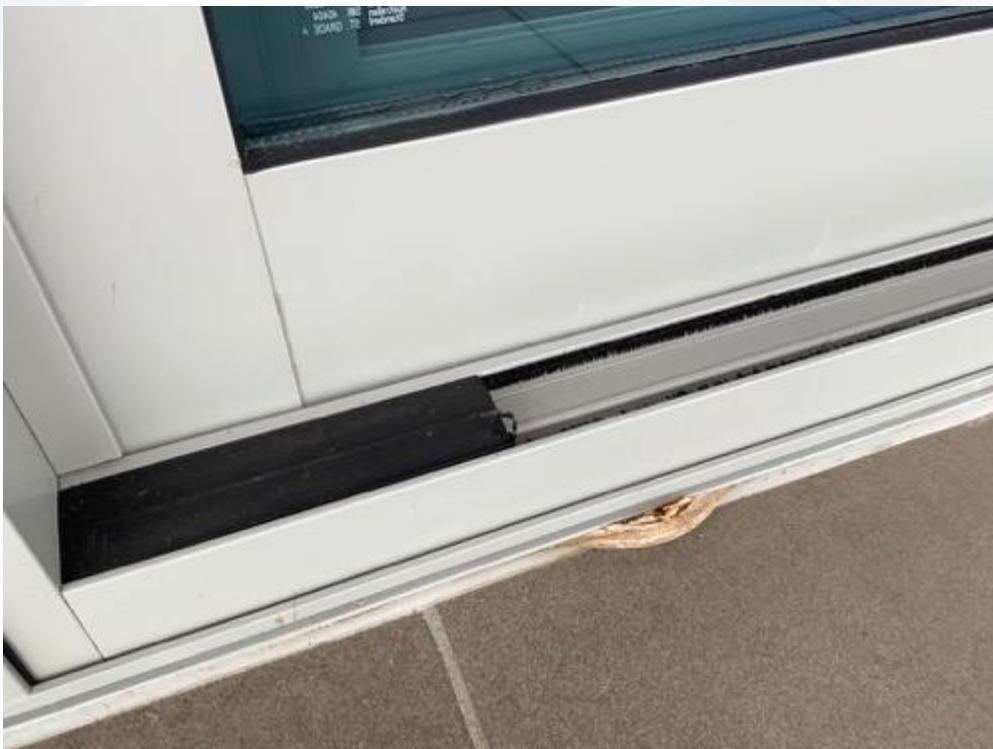
12. Sealant bulging at base of sliding door sill facing south

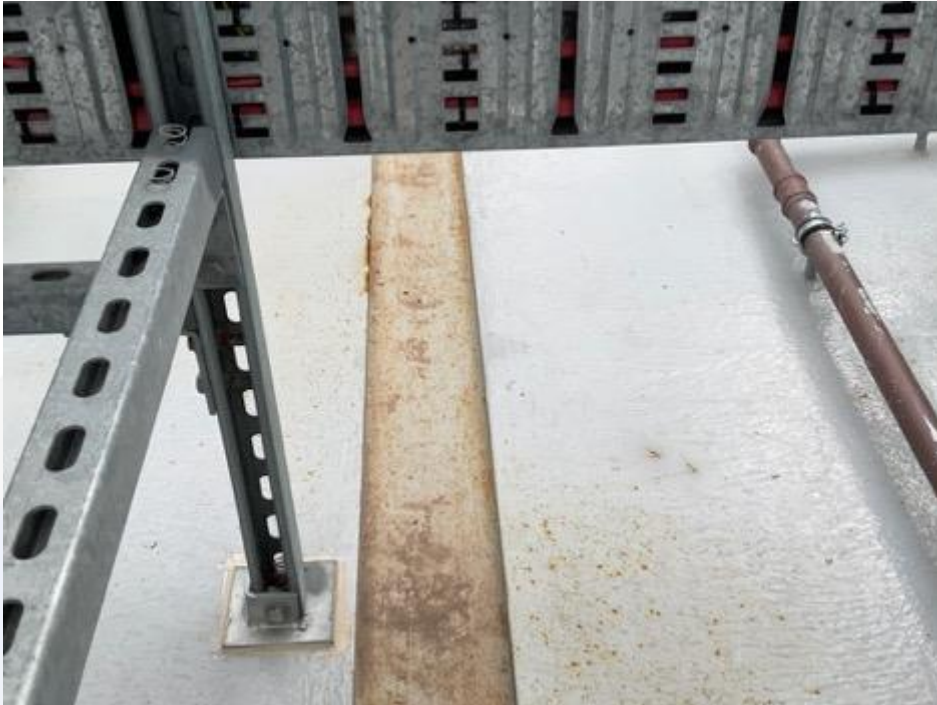
14. Rust staining in spoon drain opposite roof stair door

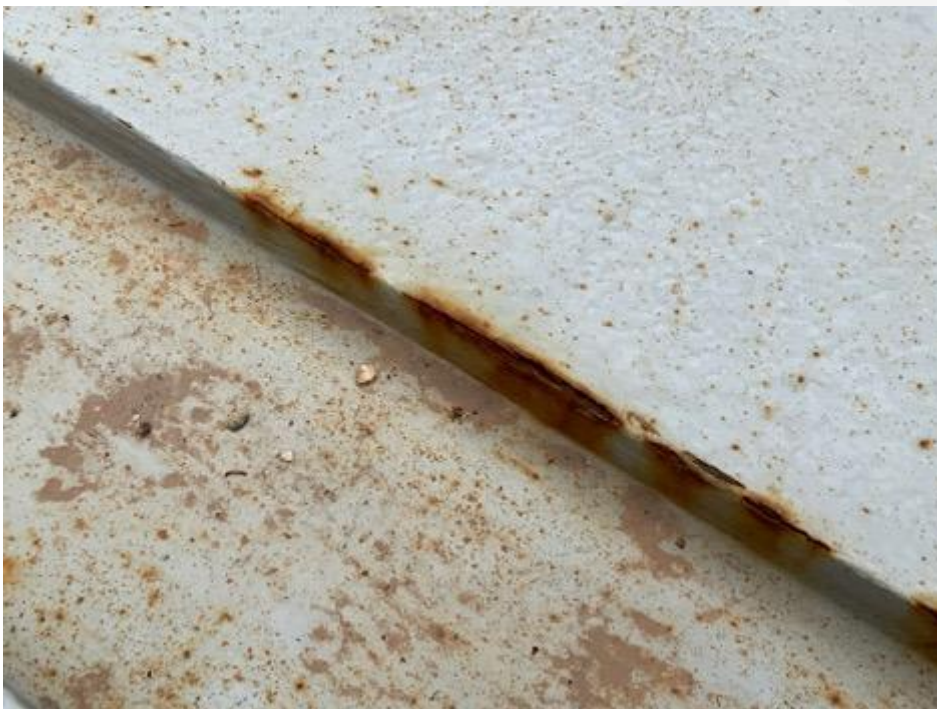
15. Rust marks in roof coating caused by grinding of metal in construction causing degradation of waterproofing

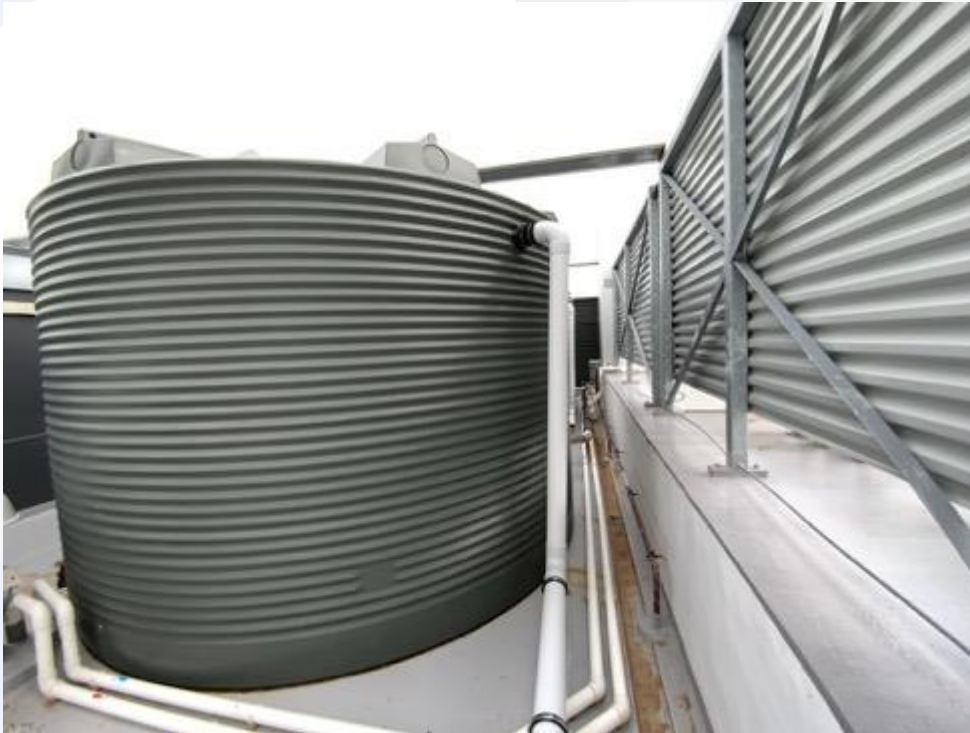
17. Water domestic water tanks x 3

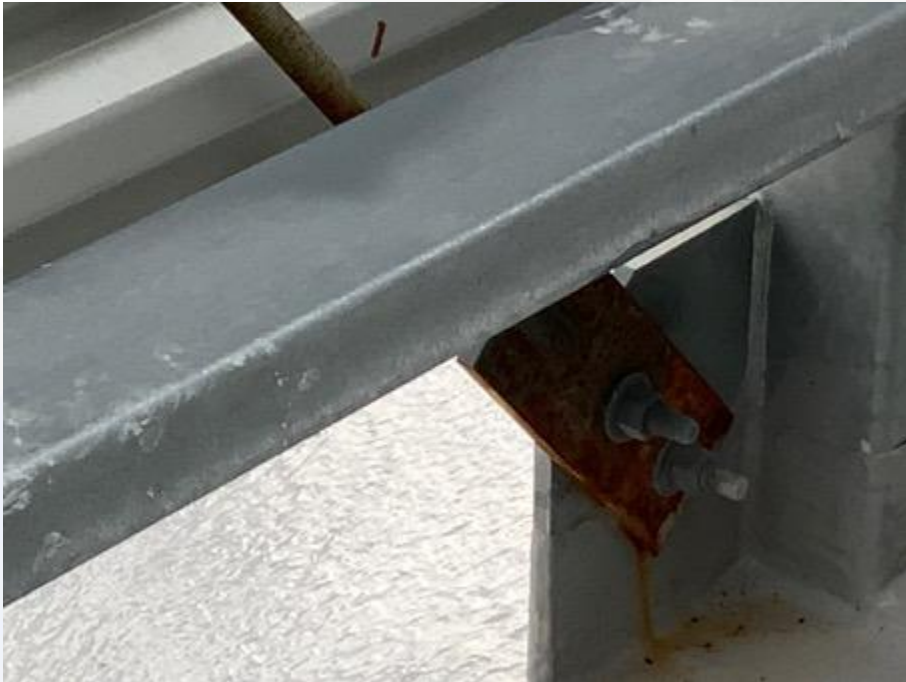
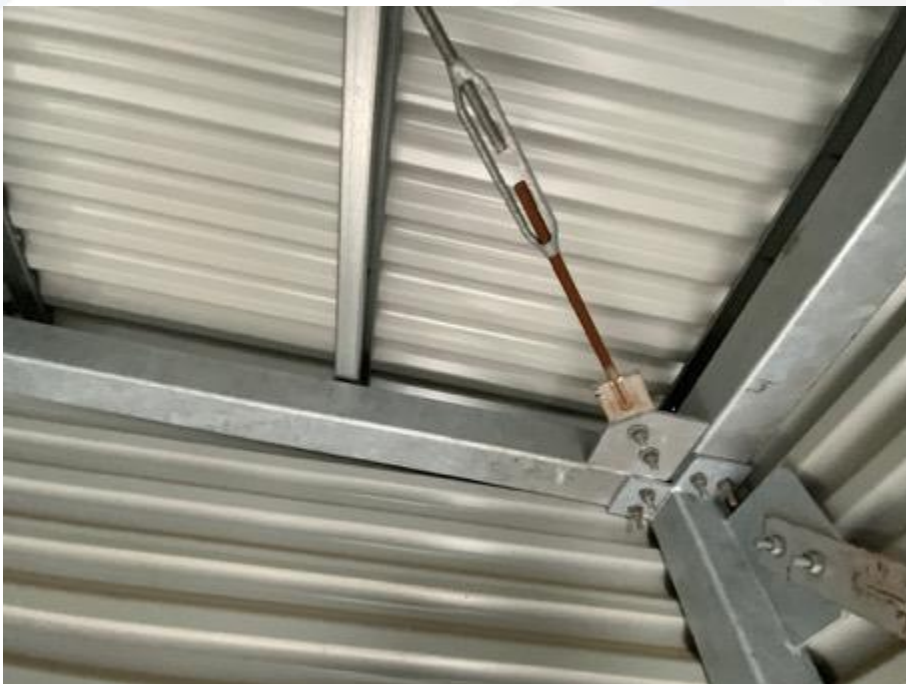
- 20. Other plant on a different level does the commercial
- 21. Replace cladding enclosures 250 m2 corrugated colorbond
- 22. Repaint gal structure 10 k
- 23. Rusting of enclosure bracing builder to rectify

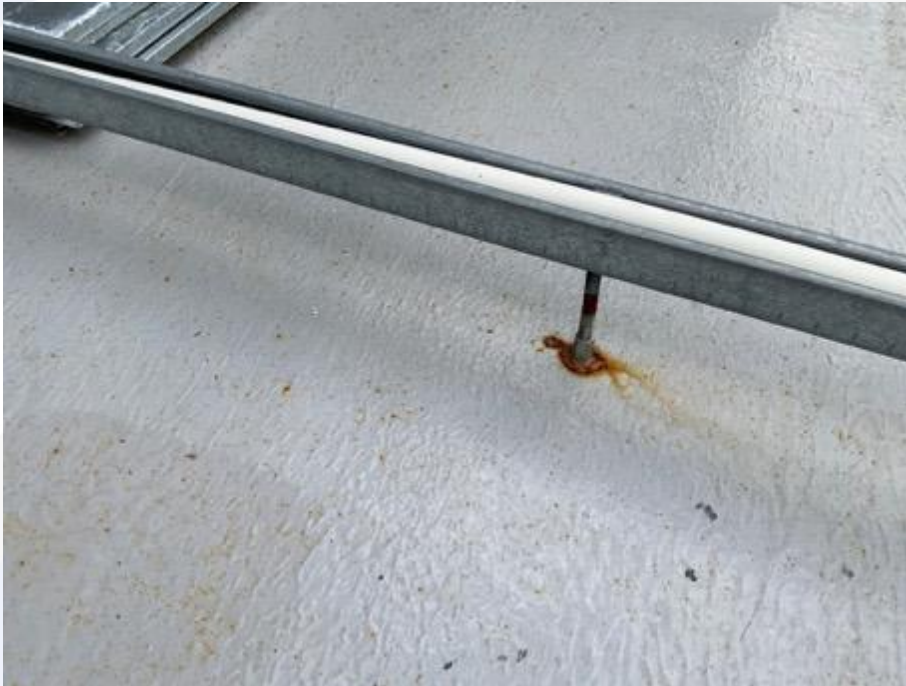
26. Rust to fixings x2 to into roof on south side stair

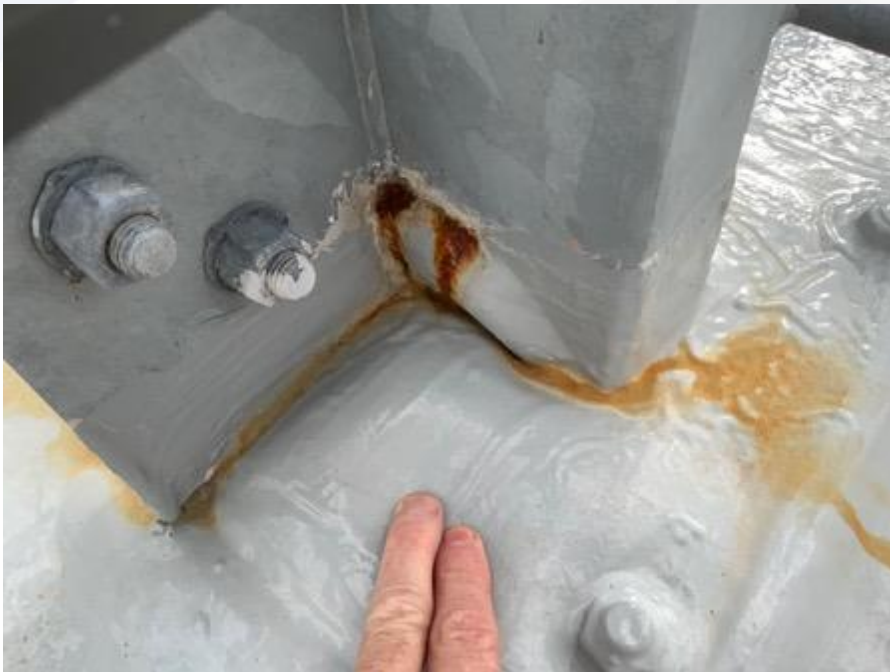
27. Large rust to base of structural fence vase on east side causing waterproofing to bubble

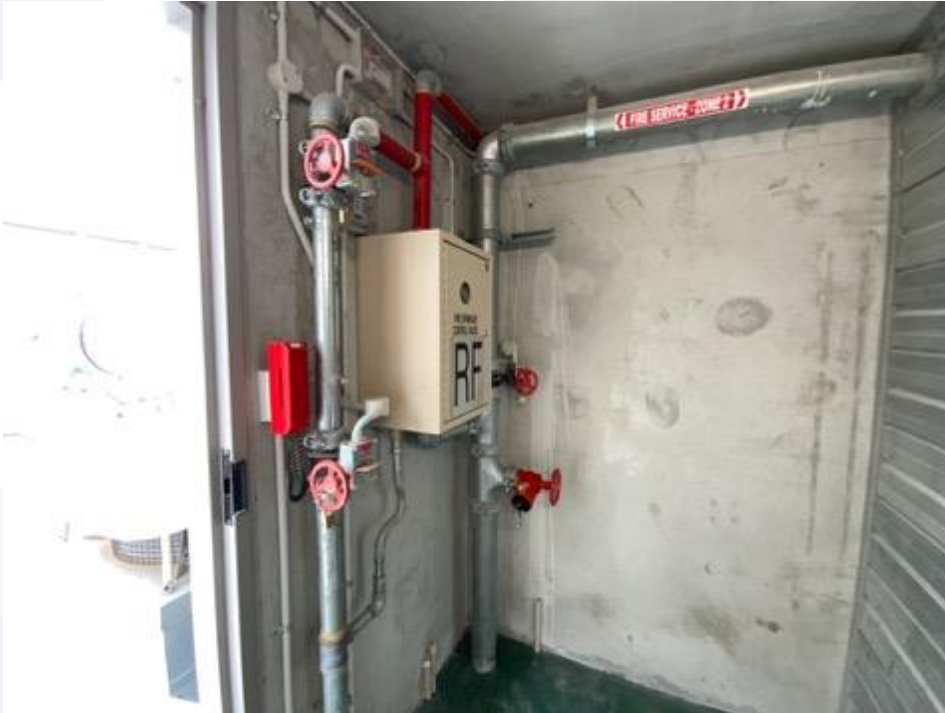
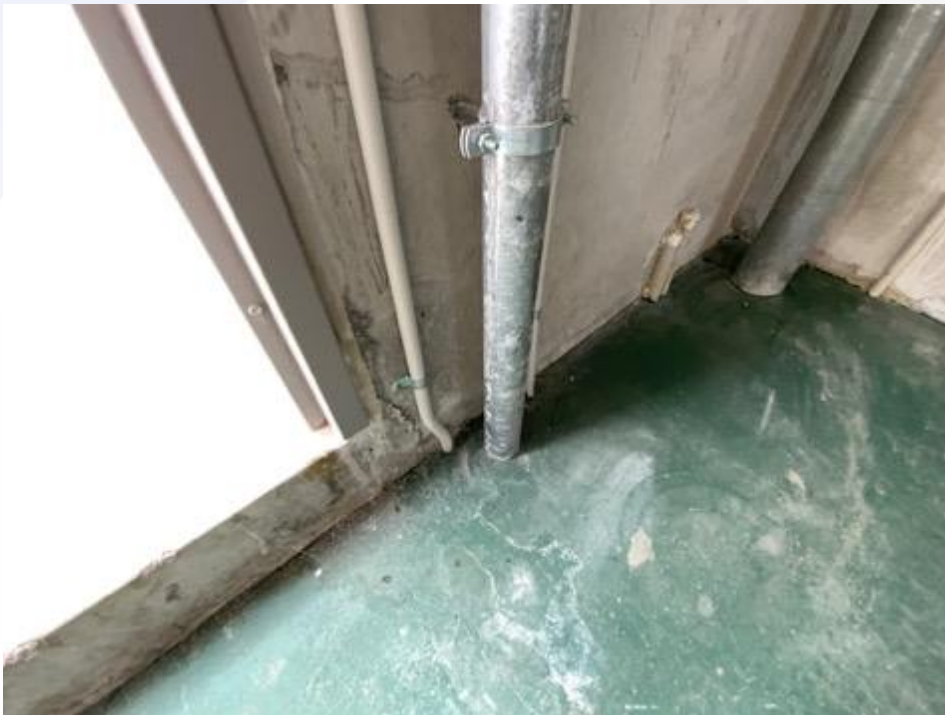
28. Clean slurry from top landing and walls surrounding fire service top of roof stair

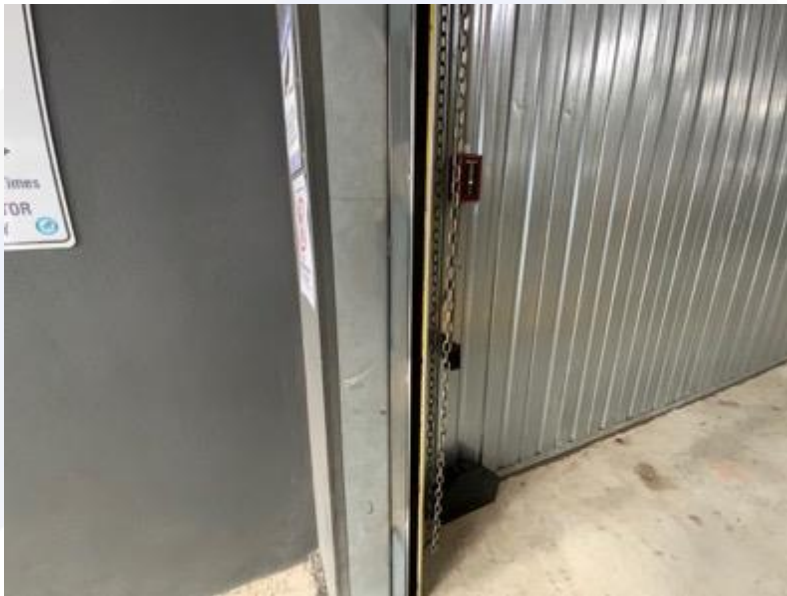
37. Priming to welds visible to carpark entrance roller door frame

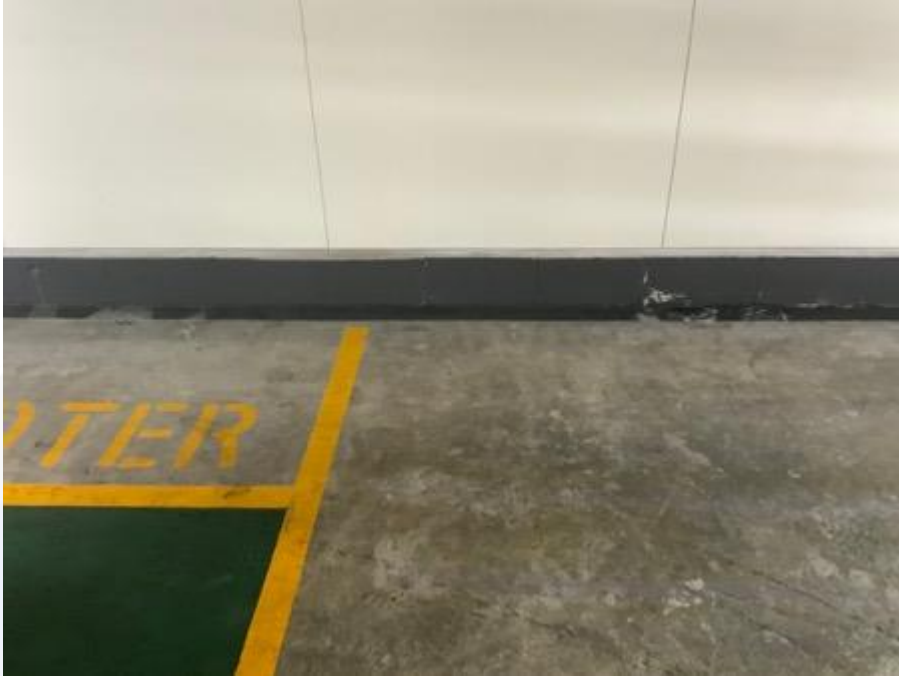
56. Ditto to west wall 1 m long to skirting opposite scooter bay

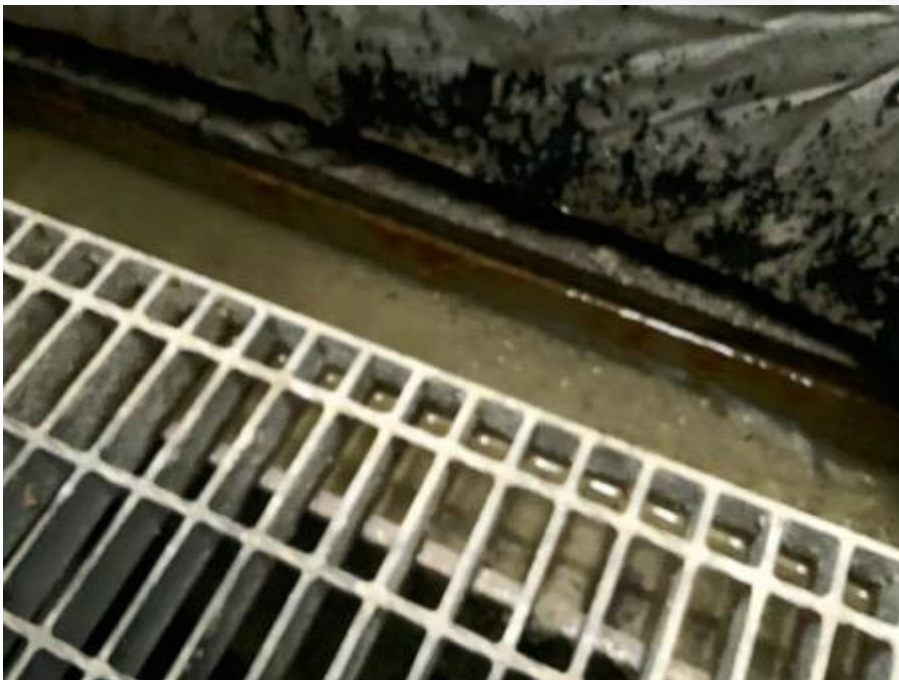
58. Water visible 100mm deep sitting in structural steel framing to north west mechanical fan room

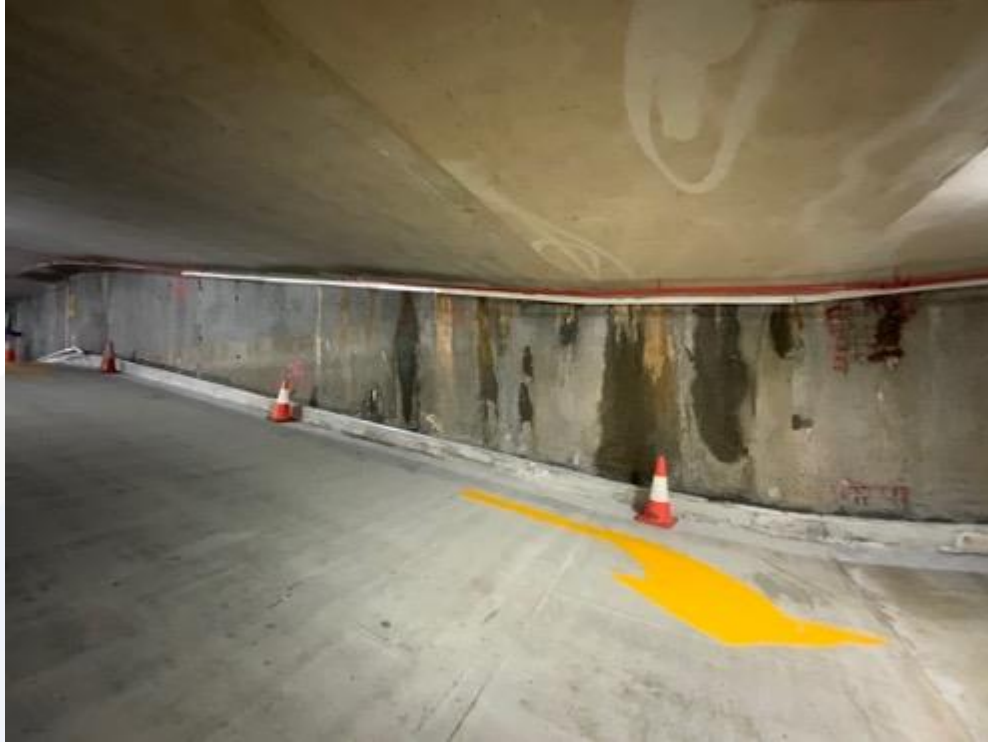
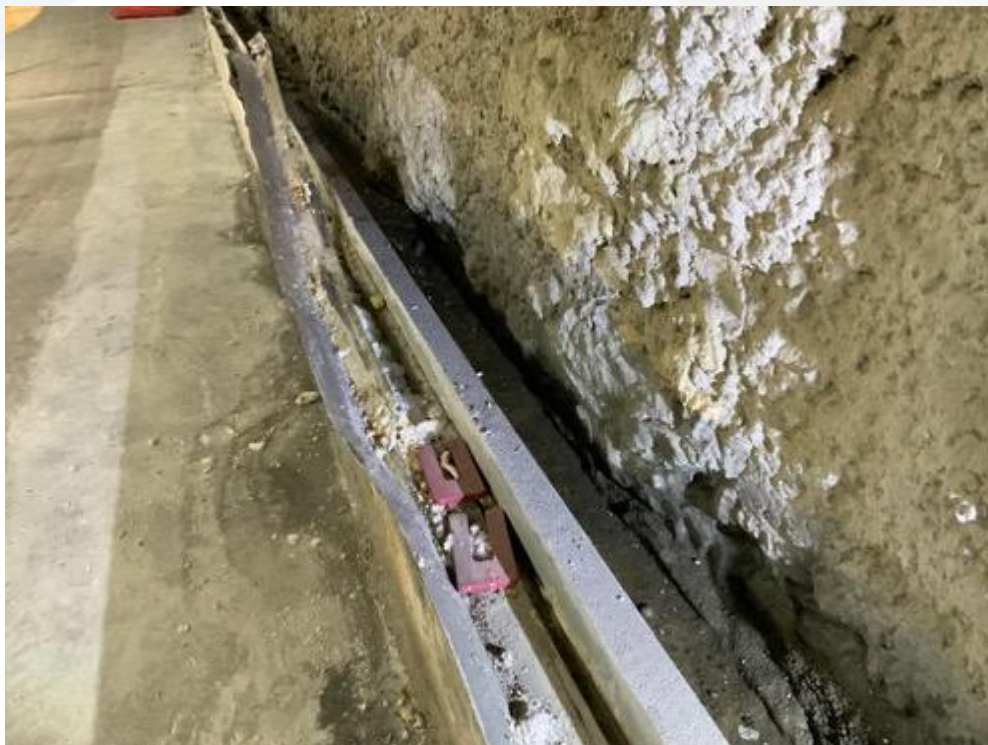
59. Photos taken 18th June 2021 workers have stripped wall and are creating a new drain and installing the new panels in front of the old 'B2 down to B3

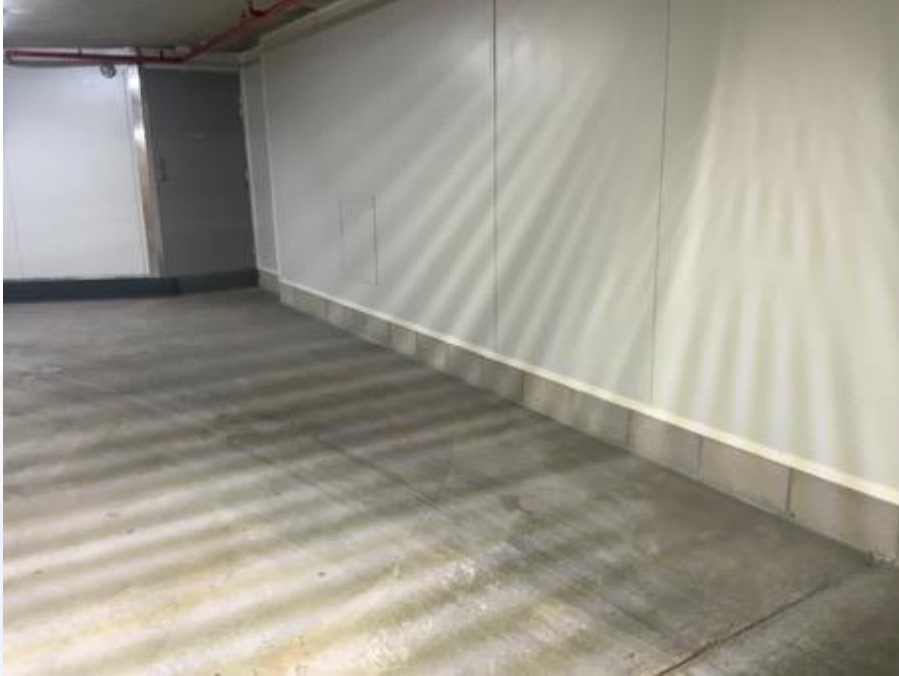
70. Ramp down to B4 leaking skirting has been repaired and looks good

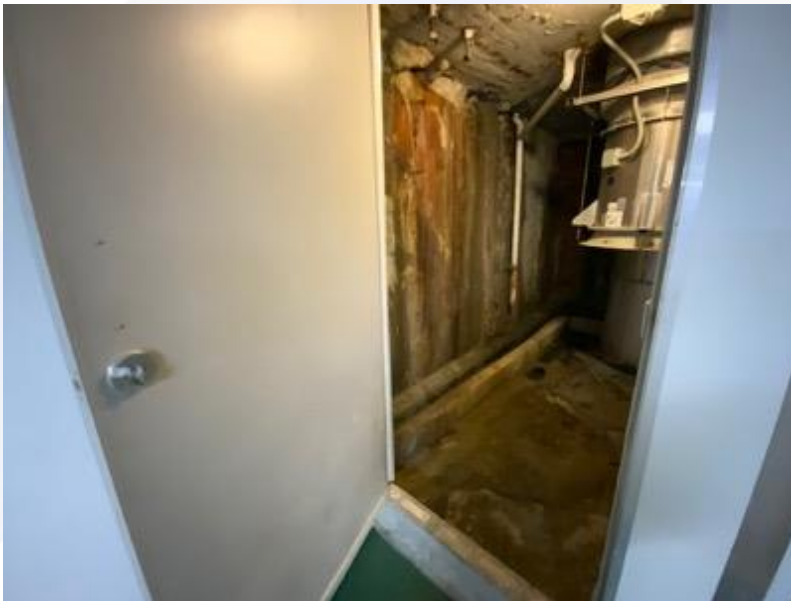
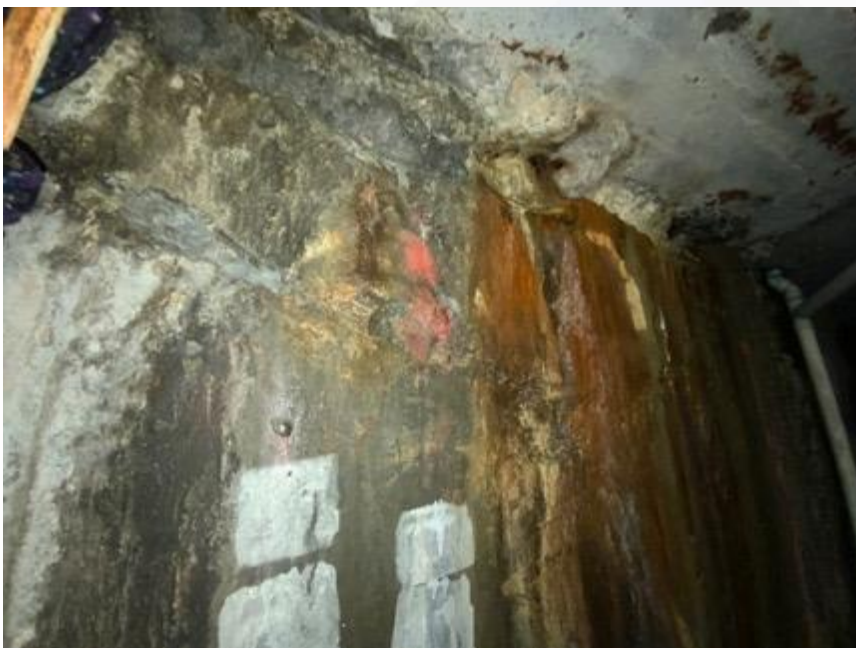
Mechanical fan room north east corner

- 72. Corroded reinforcement steel to north wall
- 73. Corroded reinforcement steel to east wall in the corner
- 74. Corrosion to fan ductwork
- 75. Corroded steelwork and reinforcement steel around duct opening concrete ceiling soffit
- 76. Walls wet and floor wet

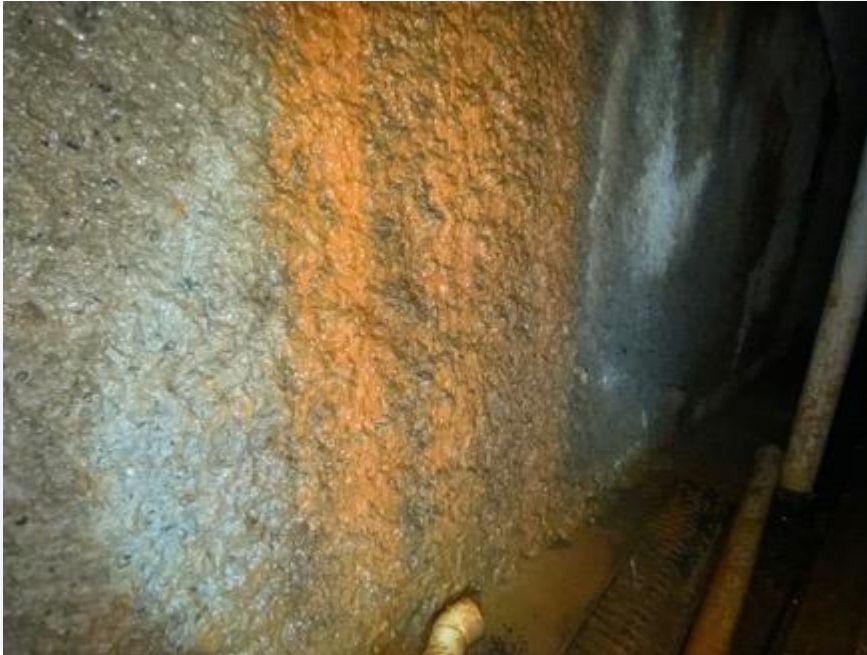
82. Leaking through wall heavy dripping water would fill a cup every few minutes directly behind the access panel. The walls either side of the access panel look reasonably dry with a few small leaks visible in both directions

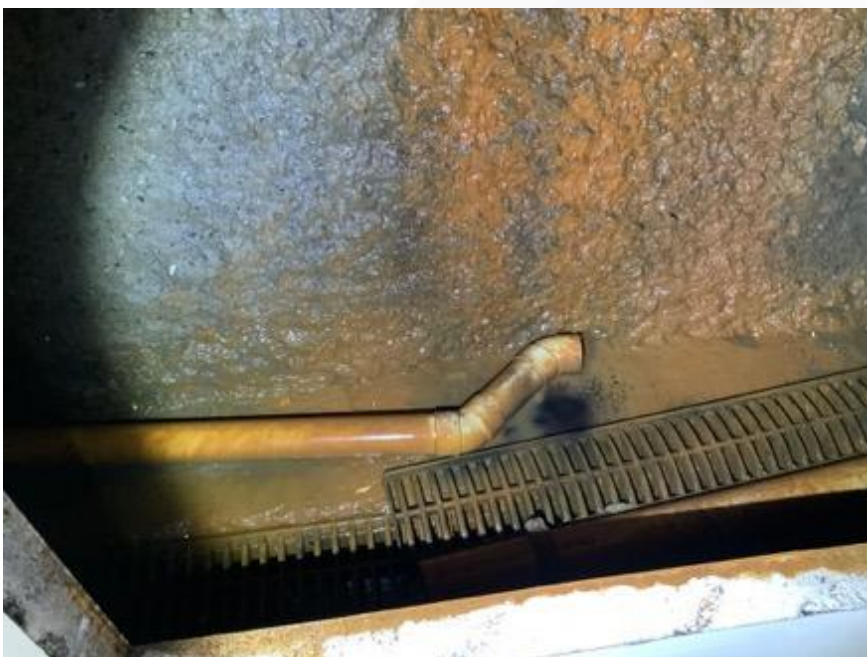
83. Garage type drain 100mm deep x 100mm wide

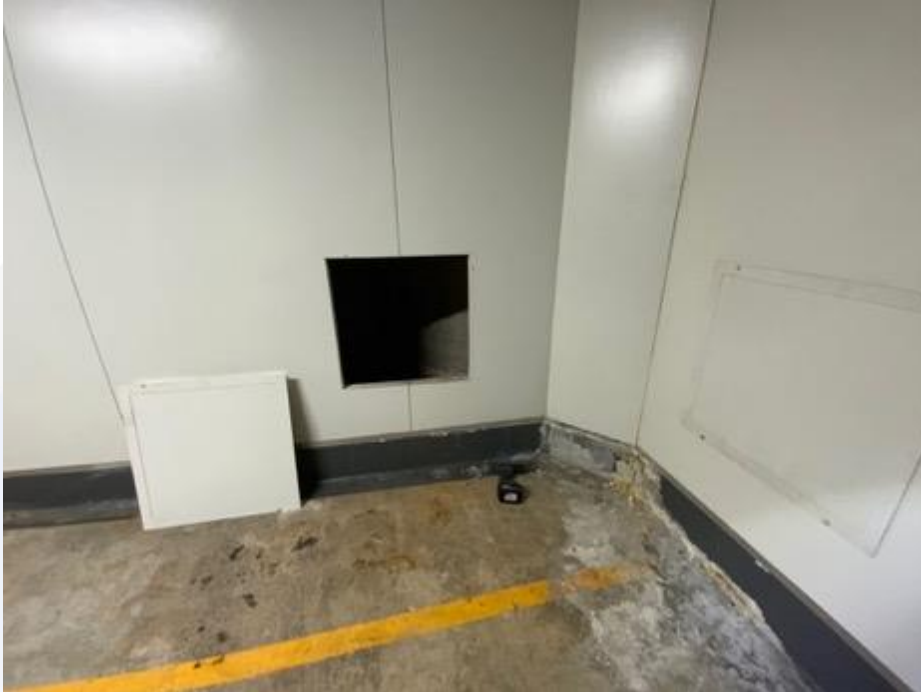
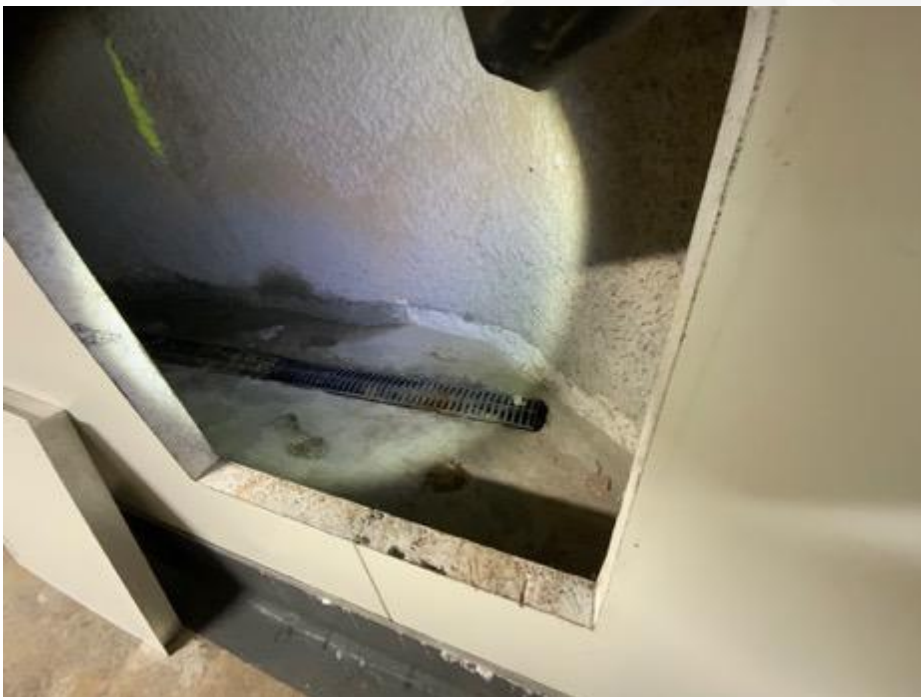
99. Leaking / flaking soffit skim coat to rear of car bay 903 caused by leaking to drain
100. Leaking /minor salt build up to skirting to west wall behind scooter bay adjacent car bay 701

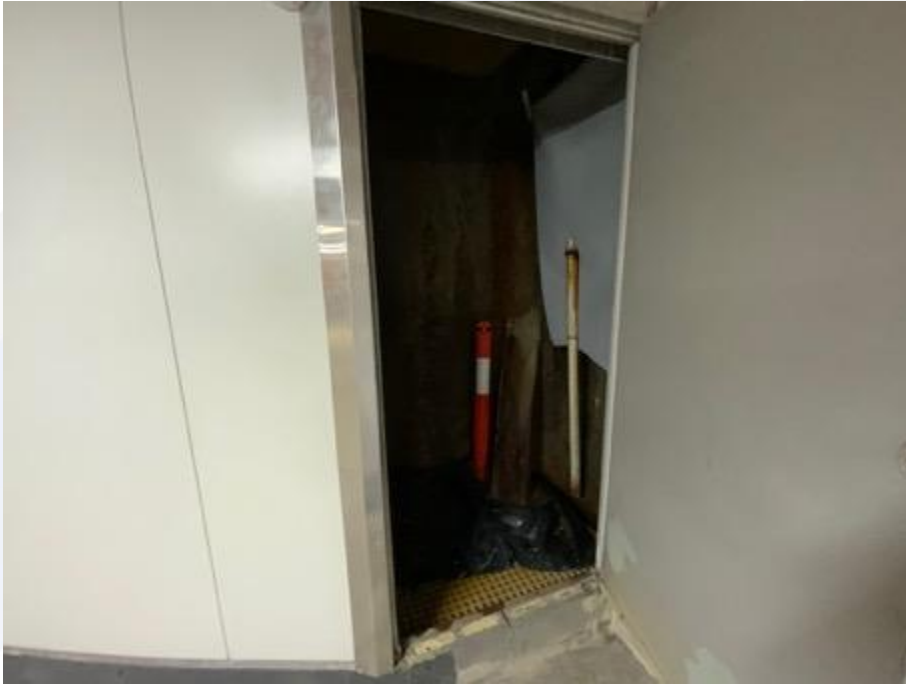
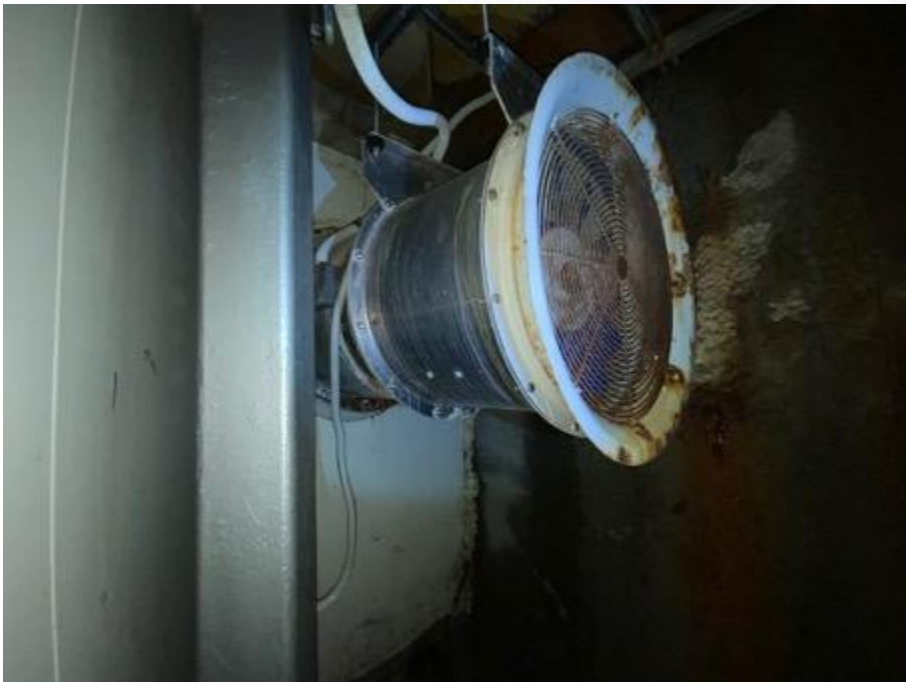
North west Mech fan room

- 108. Rusted fan unit and rusted exhaust ducting
- 109. Rusted metal apron flashing at floor level
- 110. Water running from walls west and north, exposed rusted reinforcement steel to north wall

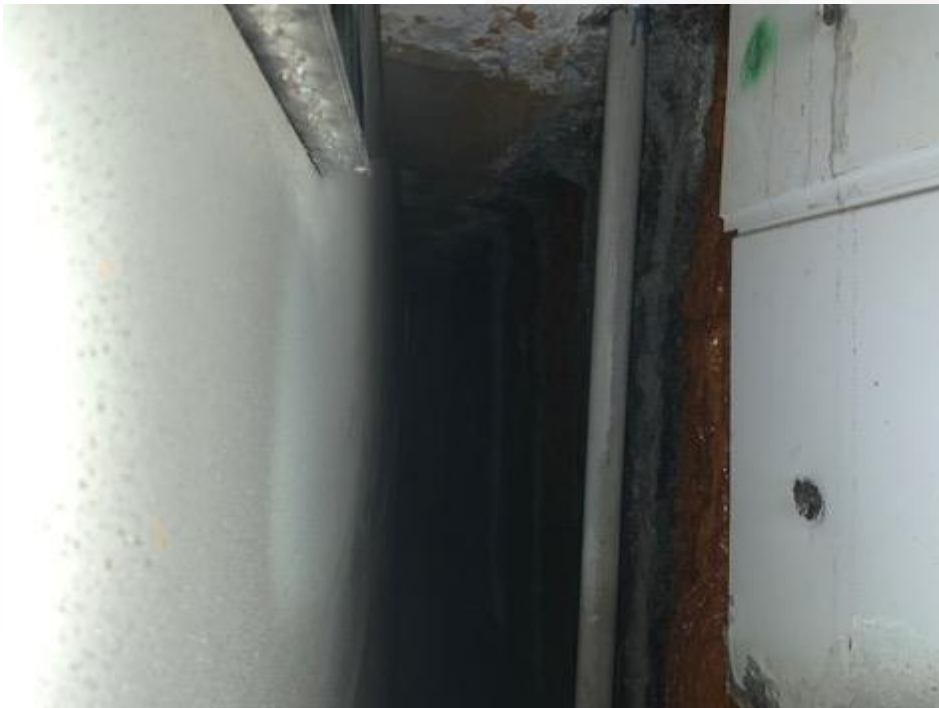
124. Water leaking through walls mainly to the north of the hatch 'red sludge' to floor is blocking drains

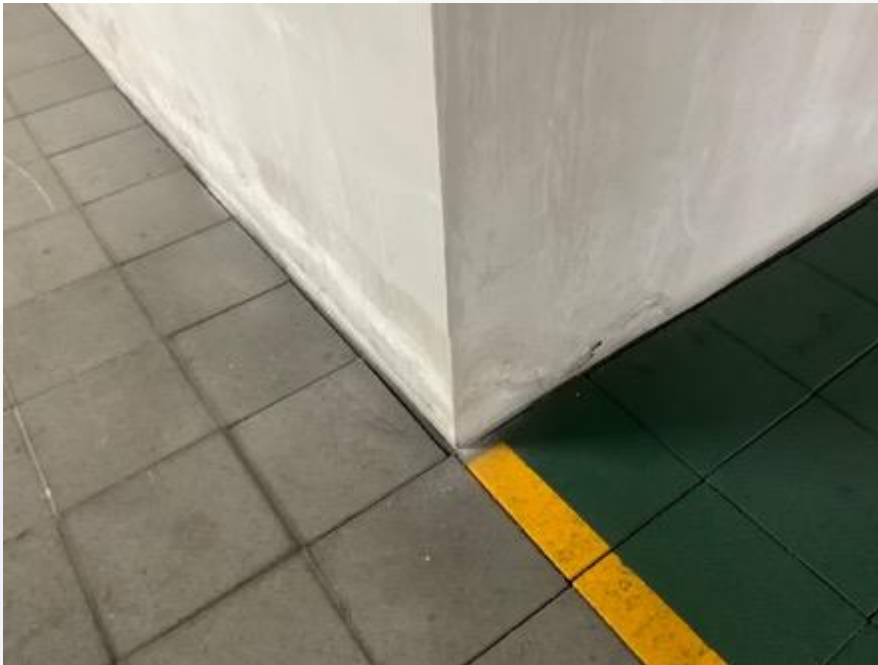
126. Render damage to south east fire stair wall facing carpark to east and south sides caused by water ingress from the floor below (previous flooding advised by building manager during construction)

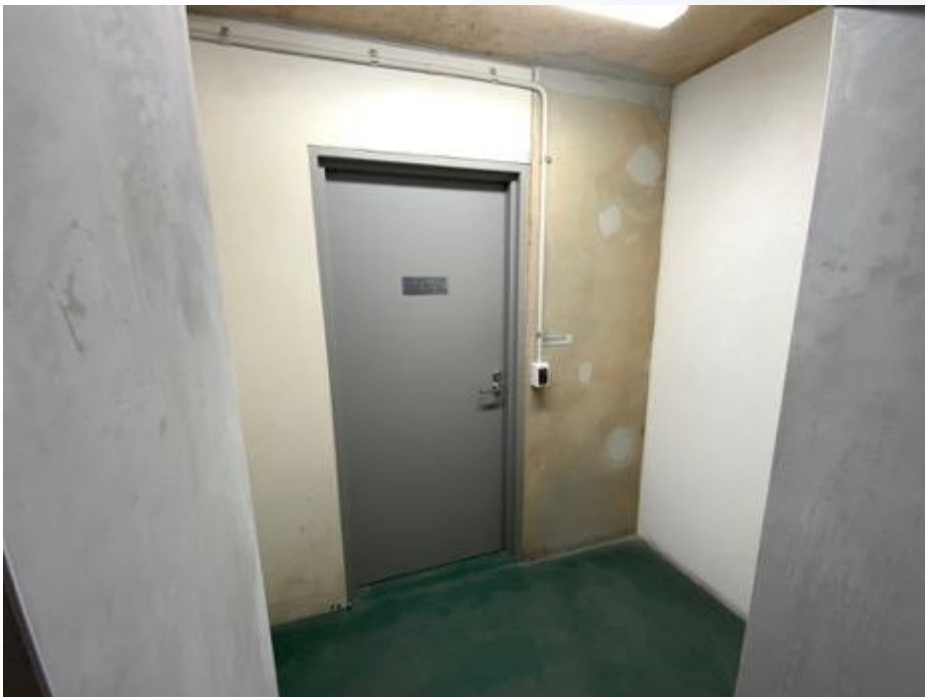
127. Unfinished wall to south facing south west stair exits, should be textured to match adjacent wall.

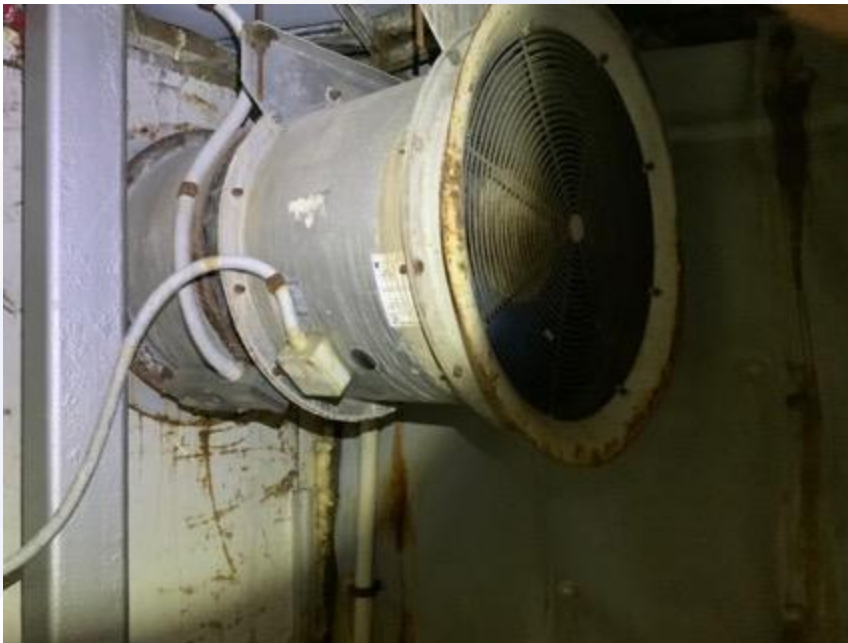
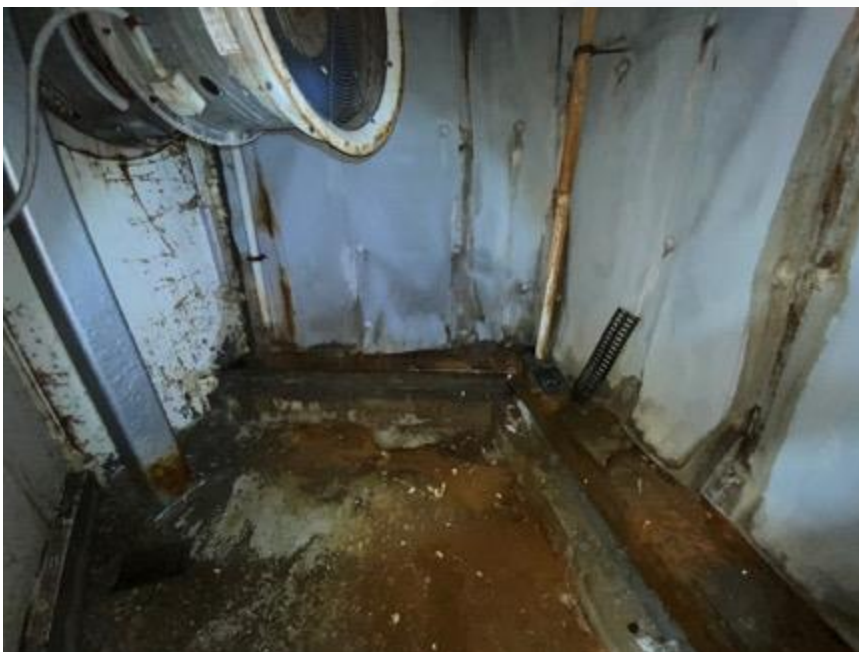
North west Mech fan room

- 131. Plastic sheet covers walls obscuring fan room walls
- 132. Rust to top and bottom of supporting column
- 133. Rust to fan and duct require replacement
- 134. Rust to structural steel frame to concrete soffit all levels

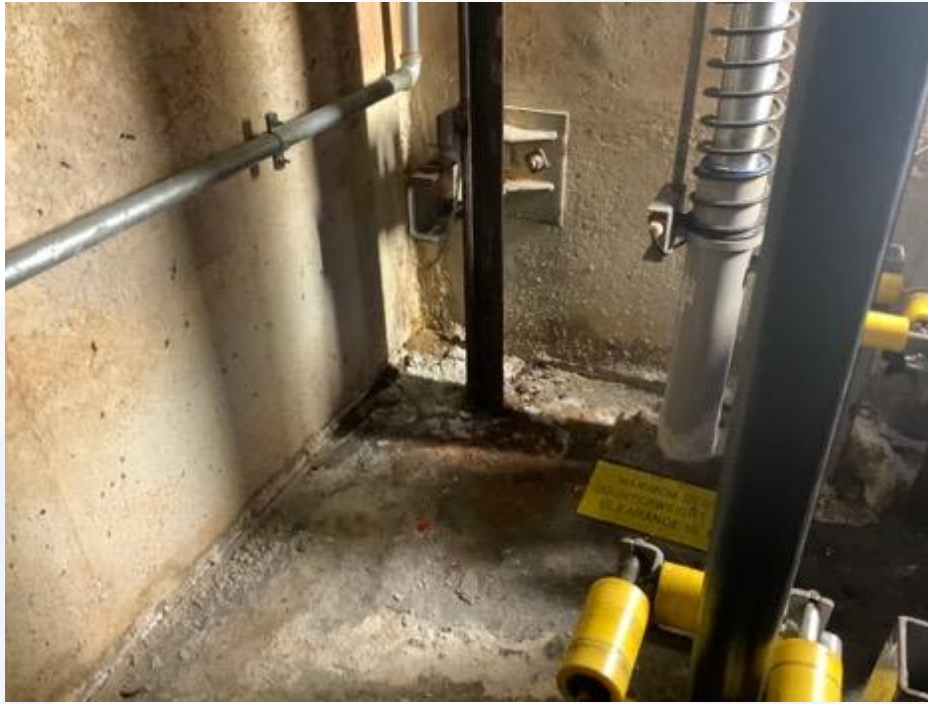
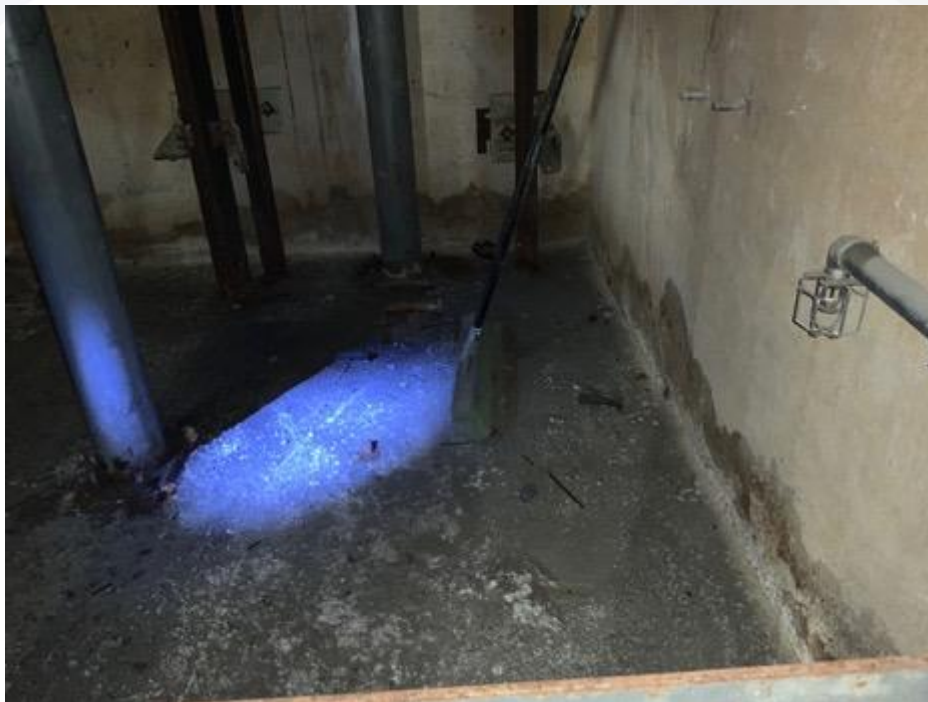
Lift Pit B5 inspection

Significant corrosion of steel lift components in the base of the lift shaft visible.
3mm layer of salt build up on the floor of the lift pit, but the base of the pit is currently dry .
