10 Year Strata Maintenance Plan

1 Harper terrace South Perth

Client Name : The Owners Strata Plan 70215
Report Number : 9870
Inspection Date : Friday 28th May -18 June 2021
Weather Conditions : Fine
Inspected by : Brian Connor B.App.Sc
Registered Builder 100541
Member of Building Inspectors association of WA

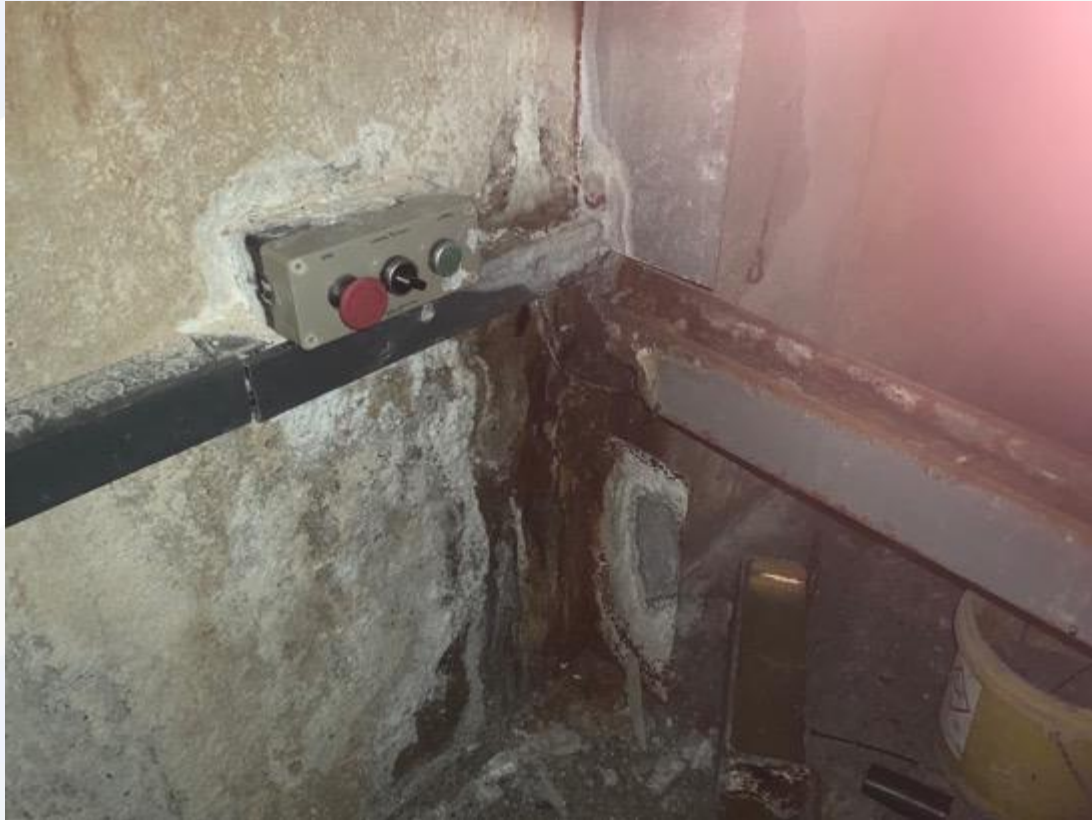
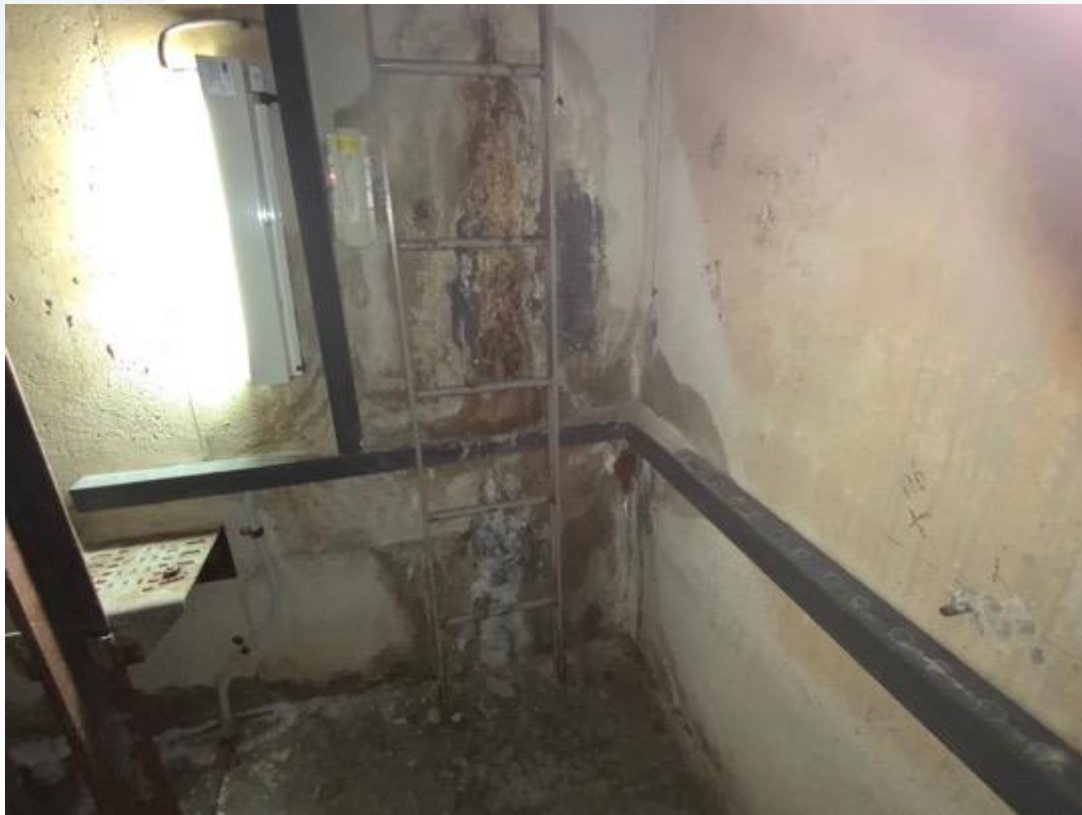
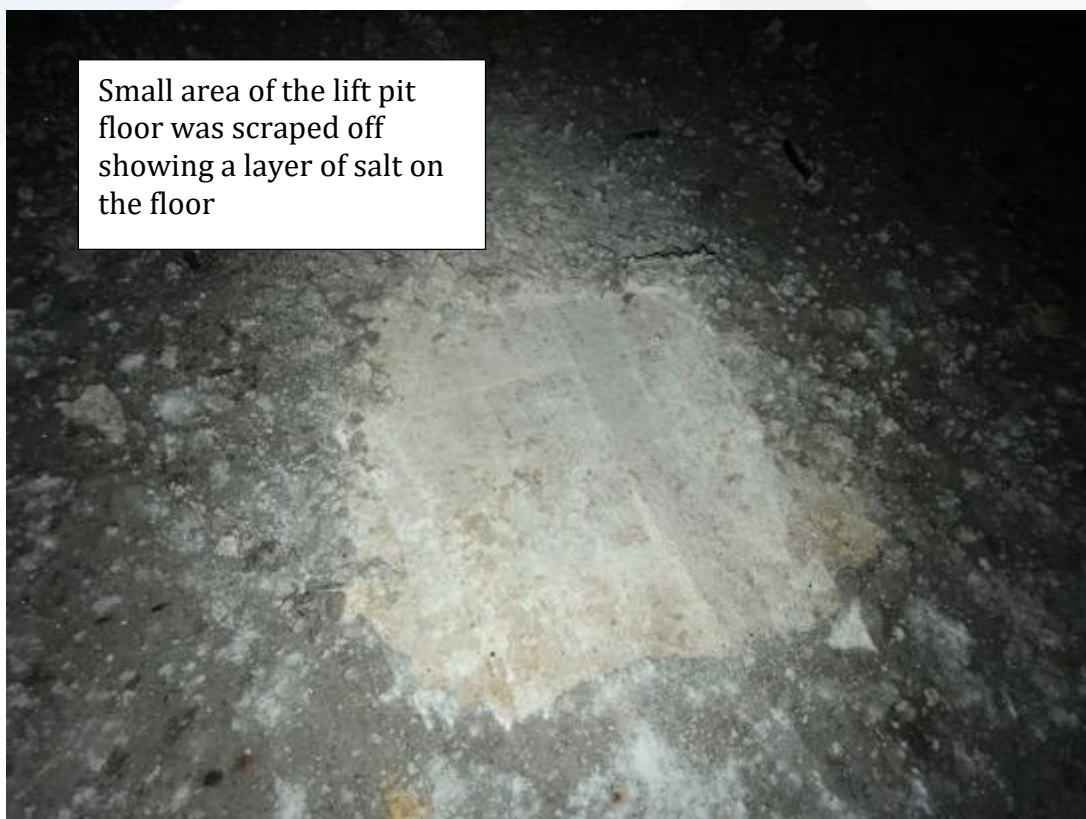
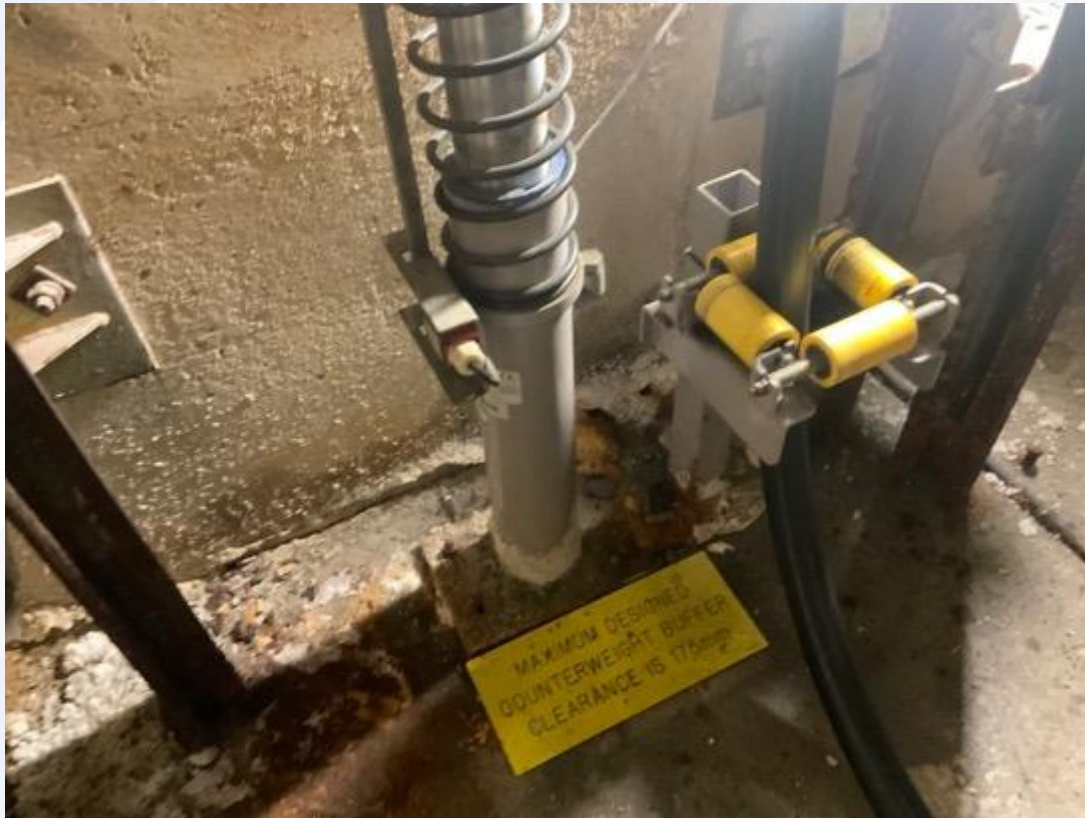
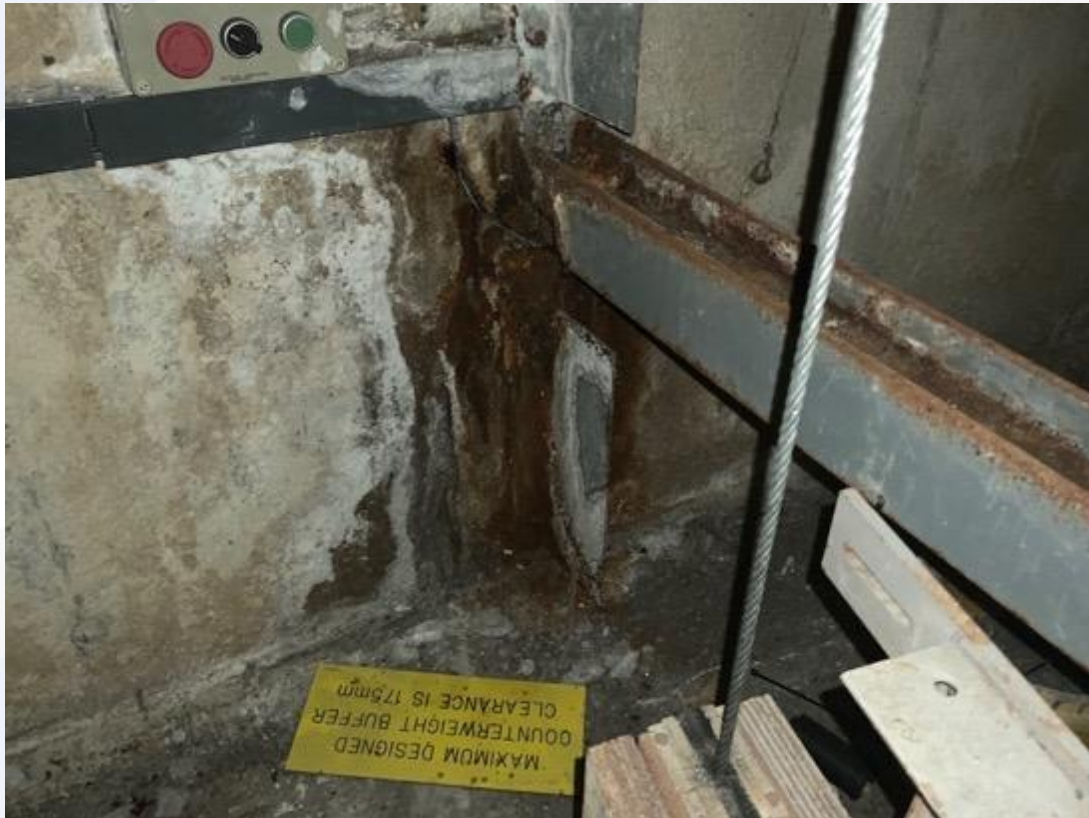
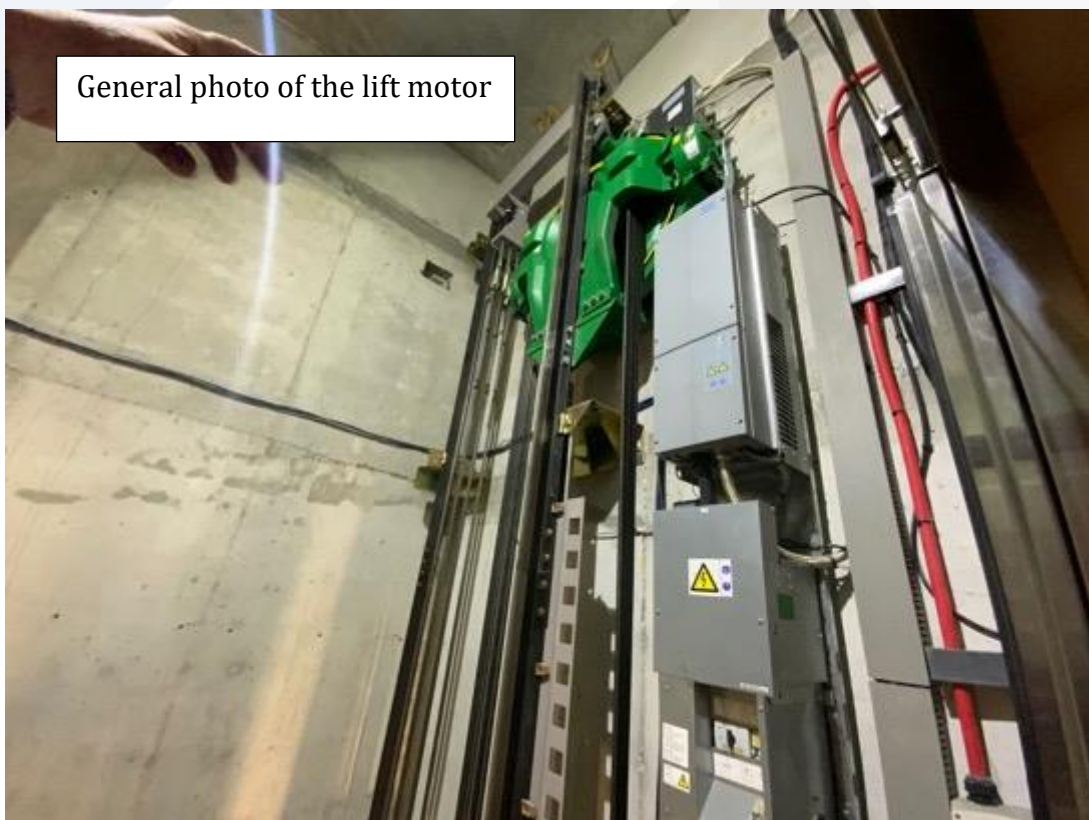
Significant corrosion of steel lift components in the base of the lift shaft visible.
3mm layer of salt build up on the floor of the lift pit, but the base of the pit is currently dry .

- Builder to rectify flood damage to B5 lift pits / corroded steel and lift components
- Builder to rectify basement water ingress issues
- Builder to replace corroded Carpark mechanical fans and ductwork

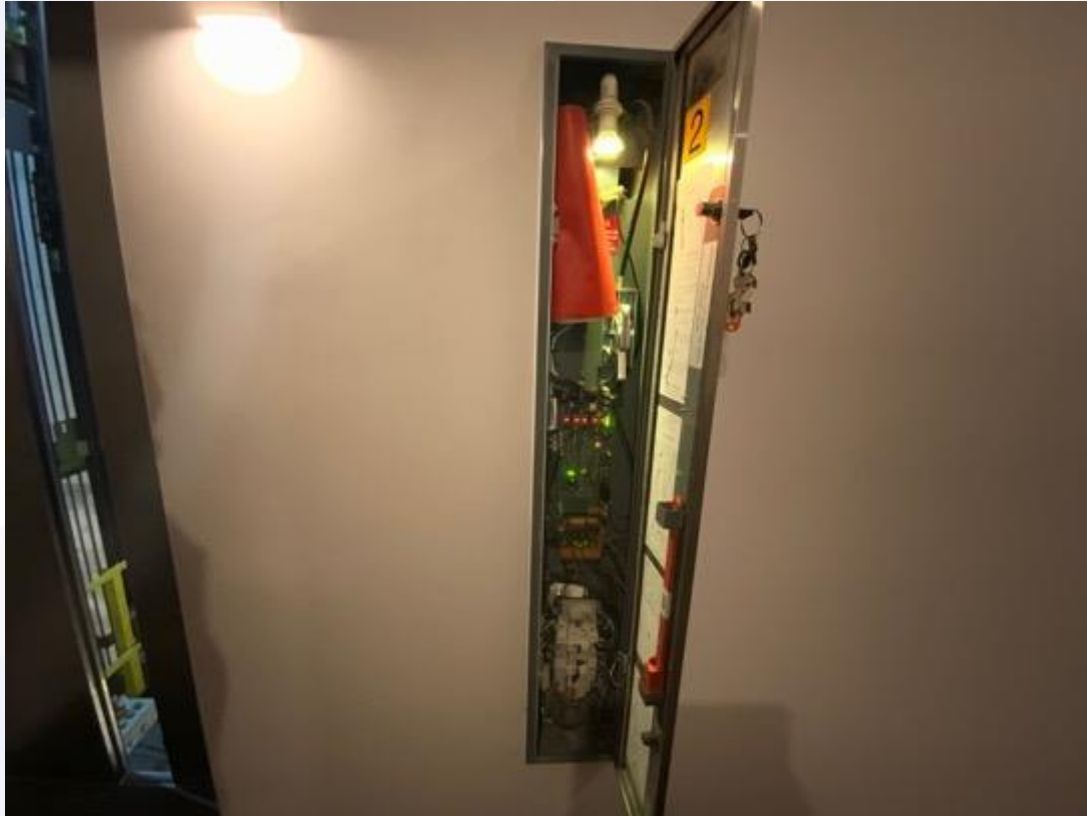
General photo of the lift motor
